# Tunneling in Mixed Face Conditions: An Enduring Challenge for EPB TBM Excavation

Jim Clark • The Robbins Company Paul Verrall • Afcons

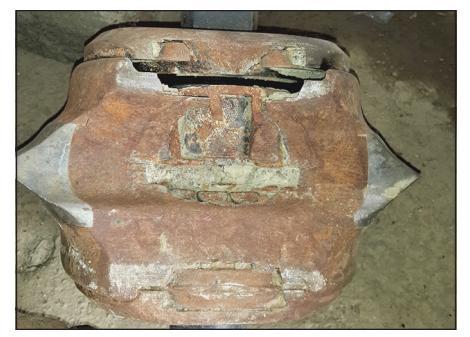
Figure 2. Damaged cutter worn flat

Analysis of the mode of cutter failure revealed that almost 90% of the cutter consumption was due to abnormal wear. A significant percentage of cutters that had been replaced had either chipping or radial cracks in the cutter discs. Many of the cracked discs had been displaced completely either by cracking or worn flat, leaving the cutter hubs exposed to the rock and resulting in the hubs being worn through to the bearings and shaft (see Figure 2 and Figure 3).

The initial observations and analysis of the chipping and radial cracks pointed to the failure mode of the cutters being caused by impact damage. Impact damage is caused when disc cutters are rotating through soft material or voids in the geology before coming into contact with hard rock. In general terms, the higher the cutterhead speed and the smaller the percentage of rock in the face, the more likelihood there is of impact damage occurs, so to confirm this theory Robbins deputed a geologist to site. The mixing chamber of the machine was emptied as low as possible to enable face mapping and rock identification was carried out. The granite in the invert was found to be fresh with weathering grade I and an estimated UCS value of 180 mPa (see Figure 4).

Although it was counterintuitive the solution to improving overall production was to reduce the cutterhead speed, restrict penetration per revolution and carry out interventions more frequently. The aim was to prevent or at the very least minimise impact damage to the cutters and to also reduce the risk of wipe-out failures. In the long term this would result in less time spent carrying out lengthy interventions to replace large amounts of cutters. Based on Robbins previous global experience and discussions with AFCONS It was decided that while boring through the mixed face conditions a baseline rotational speed of 15.0 meters per minute would be used for the outer

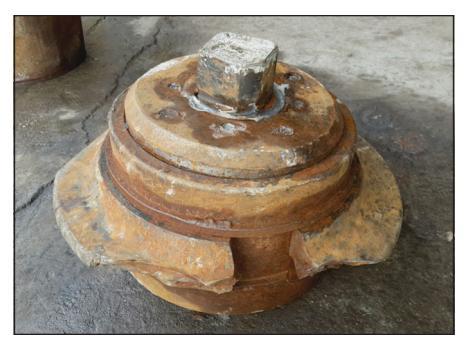
Figure 3. Damaged cutter ring

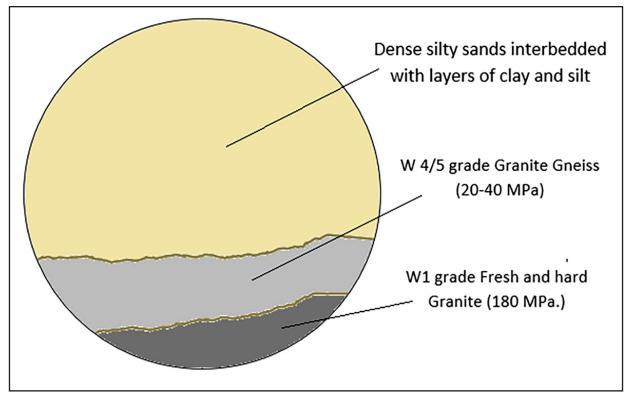
The information from the face mapping along with data showing that the cutterhead had been rotating at speeds of up to 2.6 rpm confirmed beyond any reasonable doubt

Figure 4. Face map showing mixed face conditions

that impact damage was the cause of many of the cutter failures. However, it was not the cause of all cutter failures.

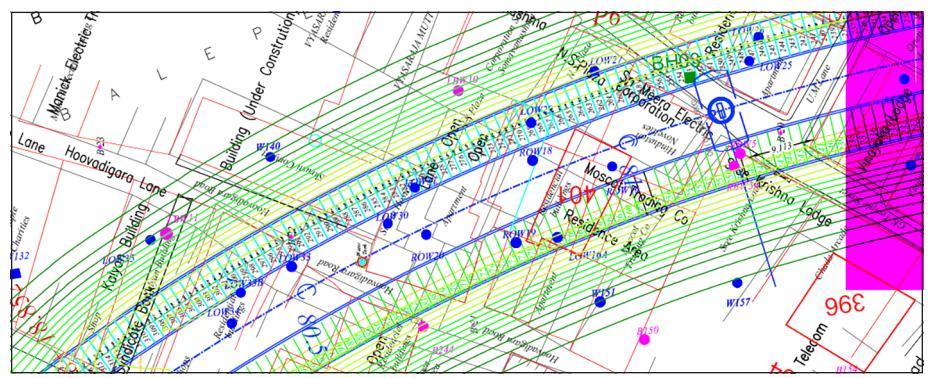
At approximately the same chainage as the machine encountered fresh granites, it also encountered both charted and uncharted wells. Numerous wells had been identified in close proximity and directly along the alignment of the tunnels. The concentration of wells increased noticeably in the 140 m stretch of the alignment beginning at ring No. 215. There are 31 charted wells (Indicated by the blue and pink spots) in the vicinity of the twin drives through this stretch (see Figure 6)

Figure 6. Charted wells in the tunnel alignment (blue and pink dots)

All charted wells had been filled and capped to prevent loss of face pressure and/ or ground conditioning foams rising to the surface. The uncharted wells were only identified by the presence of anomalies such as bottles and clay pots in the excavated material discharged through the screw conveyor (see Figures 7–8). By the time these items were discovered the machine had already passed through the wells.

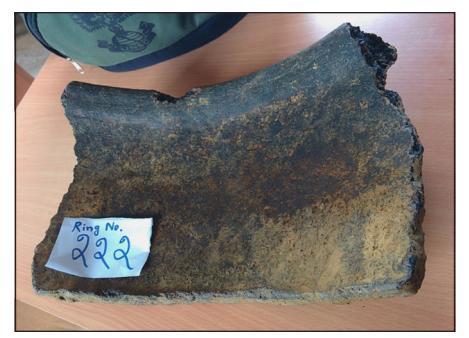
Figure 7. Clay pot found in excavated material

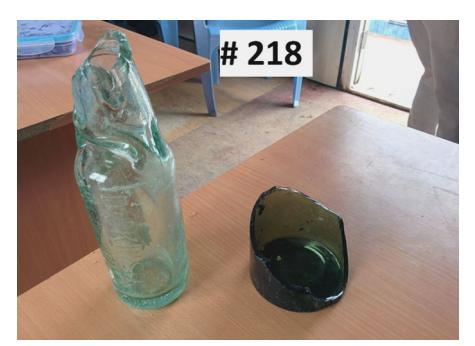
Figure 8. Bottles found in excavated material
