# The Greatest Challenges in TBM Tunneling: Experiences from the Field

**Jim Clark and Steve Chorley**

The Robbins Company

**ABSTRACT:** TBM tunneling is an ever-increasing prospect for underground construction, and with each new tunnel bored there are unknown elements. When boring through the earth, even extensive Geotechnical Baseline Reports can miss fault lines, water inflows, squeezing ground, rock bursting, and other types of extreme conditions. This paper will draw on the considerable field service experience within Robbins to analyze successful methods of dealing with the most challenging conditions encountered.

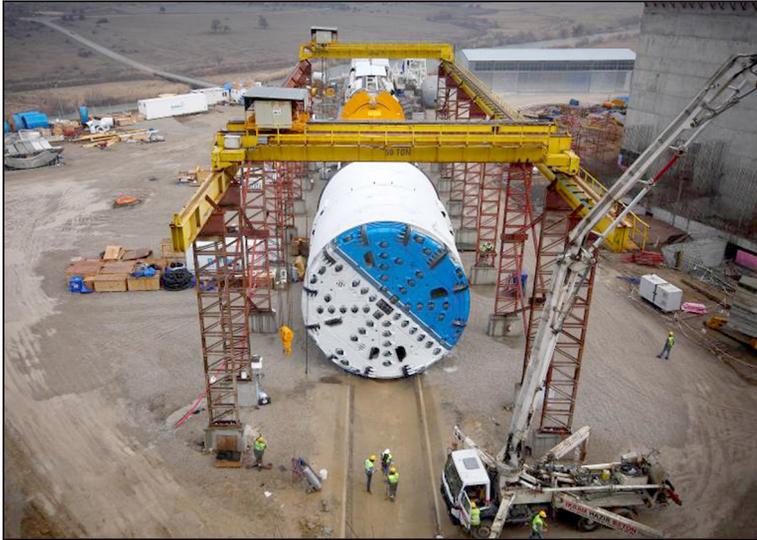
Figure 1. Double shield TBM for Kargi

The Kargi Kizilirmak Hydroelectric Project is located on the Sakarya River, near the Beypazari district of Ankara province in Turkey. The Robbins Company supplied a 9.84 meter diameter Double Shield TBM and continuous conveyor system to Gülermak for excavation of the 11.8 kilometer head race tunnel (see Figure 1). The tunnel is being driven through a mountainside with up to 600 m of overburden. The geology consists of volcanic rock and softer limestone for the first 3.0 kilometers, followed by harder rock including marble and basalt for the remainder of the tunnel alignment. Due to the variation in geology the ground support regimes range from pre-cast segmental lining for the first 3.0 kilometers transitioning into ring beams, rock bolts and shotcrete as the tunnel moves into more competent geology. Several unique features were incorporated into the TBM design to facilitate installation of the various ground support regimes.

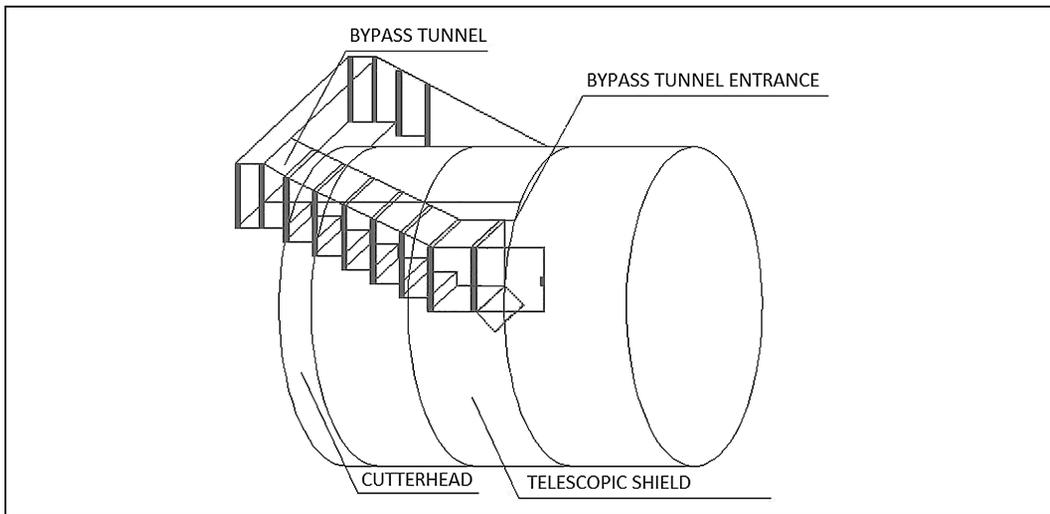
Figure 2. Bypass tunnel

After assessing all the available options it was decided that a bypass tunnel would be required. Robbins Field Service assisted Gülermak with bypass tunnel design and work procedures to free the cutterhead and stabilize the disturbed ground. Blasting techniques were ruled out due to concern over further collapses caused by blast induced

vibration; hence, the excavation was undertaken using pneumatic hand held breakers. Details of the bypass tunnel can be seen in Figures 2 and 3.

for bypass operations from 28 days to 14 days. One of the main aspects of the improved procedures was the implementation of breaking out for the bypass tunnel through the telescopic shield area of the TBM rather than the accepted norm of breaking out from the tail shield. This modification resulted in reducing the length of each bypass tunnel by over 4 meters.

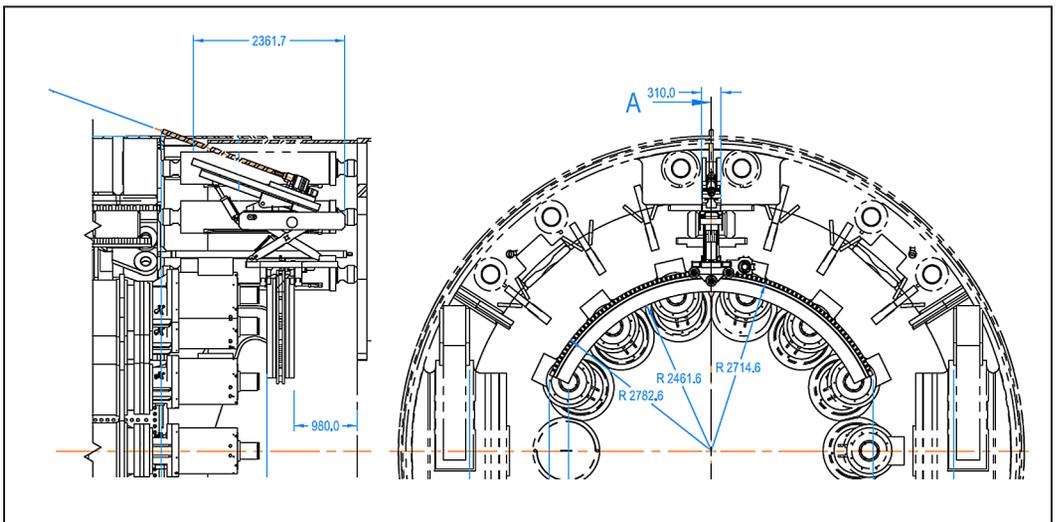
Figure 4. Custom canopy drill

The possibility of installing ground support such as fore-poles or a pipe roof canopy ahead of the tunnel face was investigated and after consultation with Gülermak a custom design canopy drill was installed in the forward shield for installation of a tube canopy (See Figures 4 and 5). The space in the forward shield area is limited; hence, the extension section of each tube is only 1.0 m in length. However the advantages

of drilling closer to the tunnel face more than compensates for the time spent adding extensions to the tube length. The location of the canopy drill reduces the length of each canopy tube by more than 3 meters when compared to installation using the main TBM probe drills. Apart from the obvious savings in drilling time, the extra 3 meters of drilling length can result in a significant increase in hole deviation. The diameter of the canopy tubes is 90 mm, each canopy typically extends up to 10 m from the tunnel face and the drill positioner, carriage and slew ring provide 130 degrees of coverage.

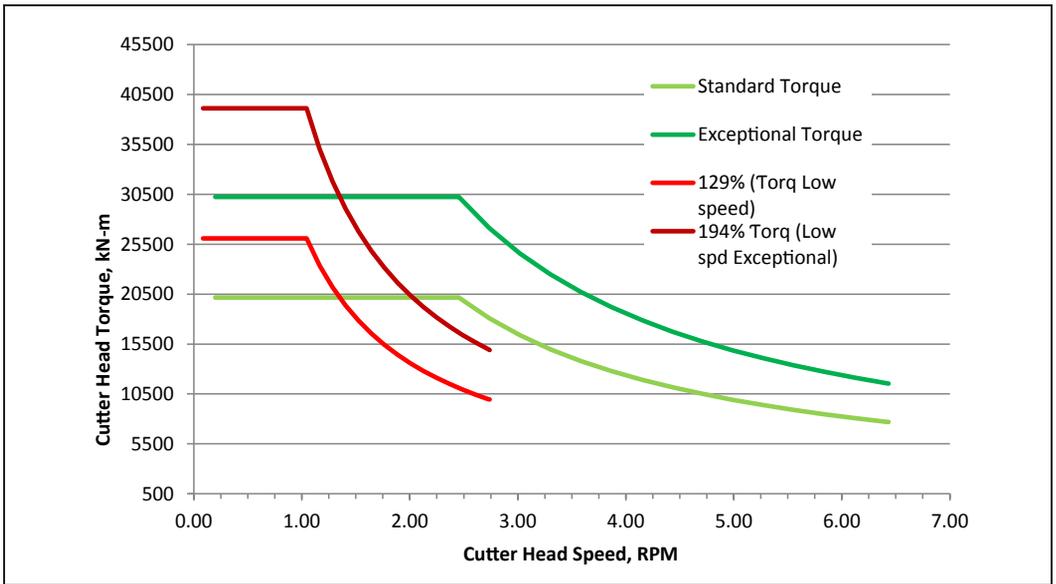
Figure 6. Cutterhead torque curves

To further mitigate the effects of squeezing ground or collapses, custom-made gear reducers were ordered and retrofitted to the cutterhead motors as a solution. They were installed between the drive motor and the primary two-stage planetary gearboxes. During standard boring operations the gear reducers operate at a ratio of 1:1, offering no additional reduction and allowing the cutterhead to reach design speeds for hard rock boring. When the machine encounters loose or squeezing ground the reducers are engaged, which results in a reduction in cutterhead speed but the available torque is increased. Figure 6 shows the torque curves for both standard and reduced gearing.

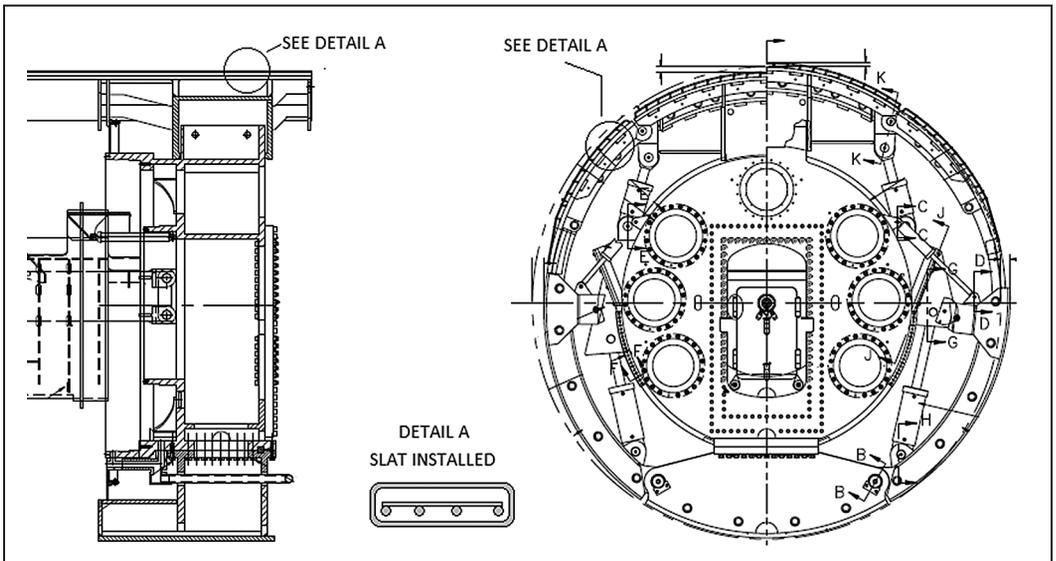
Figure 7. McNally support system

During consultations between Robbins and Odebrecht, a decision was taken to modify the machine to facilitate the installation of the McNally roof support system, which allows support to be installed directly behind the main roof shield. The main components of the initial modification consisted of removing the shield roof fingers and

forming rectangular pockets with a length of 1.4 m. The pockets run from the rear side of the cutterhead to the trailing edge of the roof support. At a later stage when the ground conditions worsened these pockets were extended to cover the profile of the side supports. Figure 7 shows details of the modifications that were implemented to enable use of the McNally System.

1. Two slats, formed from 6 mm rebar are loaded into each of the pockets.
2. The upper slats in each pocket are drawn from the pocket and pinned to the tunnel wall by means of ring beams or rock bolts.
3. As the machine advances the slats are held in place and extruded from the pockets.
4. When the leading edge of the upper slat is completely withdrawn it is fixed to the trailing edge of the lower slat, with an overlap of 200 mm. Additional slats are then loaded.

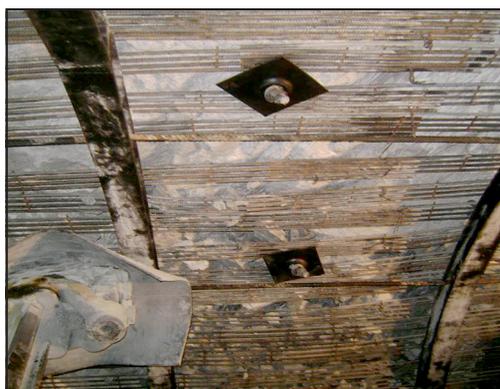
The Main advantage of the McNally support system is that is installed closer to the face than other ground support methods used on TBMs, which reduces the required standup time of the excavation. It holds loose rock in place (see Figure 8) which in turn helps to mobilize the strength of the rock mass and maintain the inherent strength of the tunnel arch. When used correctly the system can significantly reduce the time taken to provide adequate support and can also offer reductions in the level of support required.

**Figure 8. Loose rock held in place by McNally system**

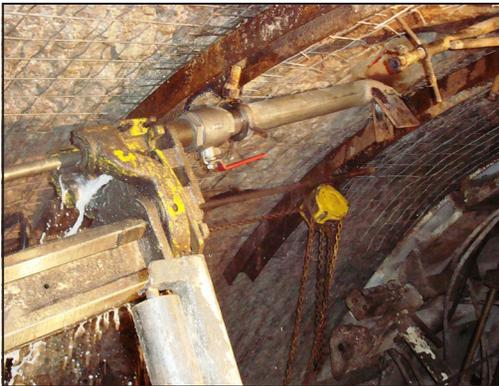
Due to the high pressure and high volume of the discharge it was decided that the best course of action would be to drill drainage holes to relieve the pressure ahead of the tunnel face, before a programme of consolidation grouting could be undertaken. Both drainage holes and grout holes were to be drilled via standpipes. The design of the standpipe arrangement consisted of drilling a 75 mm hole 5.0 m deep, inserting a 6.0 m long, 64 mm steel pipe with a threaded section on the trailing end, and anchoring the pipe in place by cement grouting. A ball valve and pressure gauge were attached to the threaded end of the pipe.

A third probe hole (P3) was drilled utilizing the standpipe arrangement, to a depth of 38 meters. Although the location of the P3 probe hole was adjacent to the P1 probe hole location at the 10 o'clock face position, it did not encounter silt or high pressure water. The next course of action was to attempt drilling a fourth hole that would intersect probe hole P1 to facilitate drainage operations. The hole was drilled through a standpipe which was subsequently fitted with a valve to enable regulation of flow, a pressure gauge and a length of 75 mm hose to allow drainage of material directly into the tunnel muck cars (see Figure 8).

Figure 8. Drilling through stand pipe at Parbati

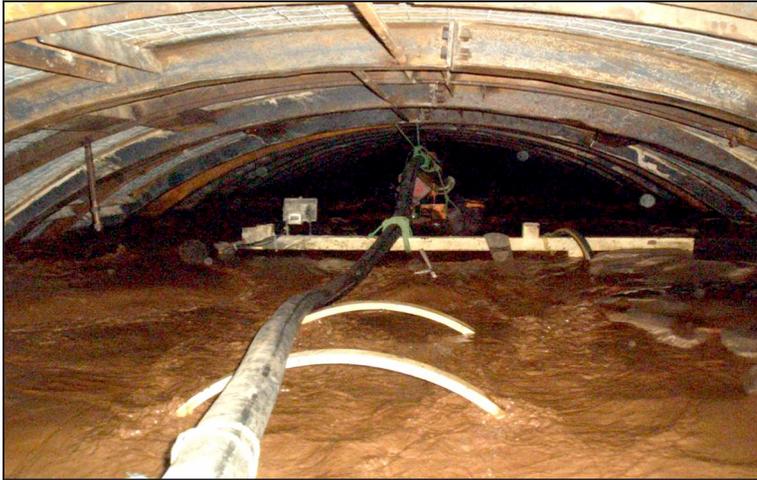
pressure gauge and minor inflows of silt and water began to flow through fissures in the rock mass close to the face. Further rock bursting fractured the rock mass surrounding the collar of probe hole P1 causing the rock to fall away and expose the hole behind resulting in an inrush of water and silt under massive pressure. The crew tried unsuccessfully for several hours to insert a packer into P1 to stem the flow of material but at 7:00 am with silt levels rising rapidly and rock bursting continually occurring, the tunnel was evacuated for safety reasons.

During the 25th November it was deemed impractical and unsafe to enter the tunnel. Water ingress was measured at the portal throughout the day and flow rates gradually increased until they exceeded 7000 liters/min. On the 26th November flow rates stabilized so a team entered the tunnel to assess the situation. They observed that the inundation had almost completely buried the TBM (see Figure 9) and that silt and water were still flowing from the probe hole. However the pressure of the discharge had reduced and a crew was mobilized and managed to seal the probe hole by inserting a mechanical packer. The total amount of silt deposited during this event was over 14,000 m<sup>3</sup> and the cleanup operation took over 2 months.

Figure 9. Parbati TBM buried in silt
