EPB excavation of less than five meters below the historic structure of Chandpole Gate on the Jaipur Metro Project

ABSTRACT: The tunnels excavated by Continental Engineering Corporation (CEC) for the underground section of the Jaipur Metro project faced the usual challenges posed by metro projects worldwide, including small site footprints, and the associated problems regarding segment and muck storage space, etc. These challenges were, however, relatively straightforward when compared to the challenges faced by the tunneling operations. The Earth Pressure Balance (EPB) TBMs were required to bore under extremely low overburden, alongside and beneath several culturally sensitive historic structures. The age of these structures and their construction methods/materials were of great concern when considering the possible consequences of tunneling-induced ground settlement and vibrations. This paper will describe the measures taken regarding TBM operations and surface monitoring to ensure that these historic structures suffered no adverse effects due to tunneling.

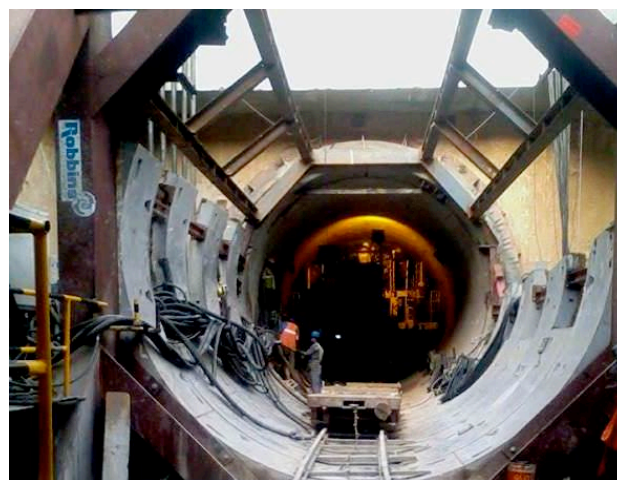
Figure 5. Temporary rings

This is a common practice in shafts with limited space as it provides additional access for lifting and lowering of muck cars and segments; however, this meant that the traditional methodology of increasing thrust force on the upper quadrant of thrust cylinders to steer the machine in a downwards direction could not be fully utilized. By the time the whole of the TBM had passed through the tunnel eye the machine was 240 mm above design alignment. It was also left of center due to the majority of steering efforts having been concentrated on preventing the machine from rising. At this point, additional longitudinal supports were installed between the first permanent ring and the reaction frame (see Figure 5).

Installation of the additional supports made it possible to substantially increase the thrust force in the upper quadrant of thrust cylinders and as

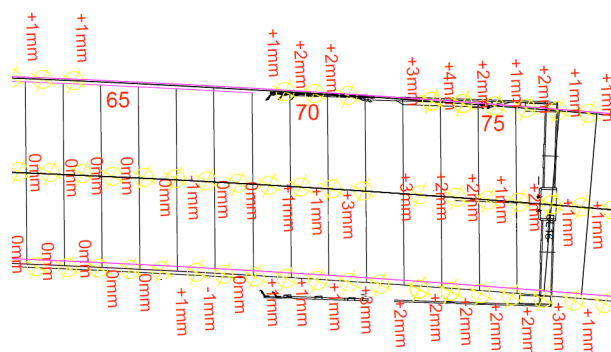
Figure 8. Surface monitoring points

The TBM was now beneath a busy arterial road, which meant that continuous monitoring of the datum points on the surface could not be carried out. However, due to the short start-up and restricted length of the TBM conveyor only one muck car could be used at a time. Four muck cars were required to complete the excavation of a 1.2 m ring; hence, a regime of monitoring the surface points after every 300 mm of boring was initiated by intermittently holding up traffic. The results of the monitoring were relayed directly to the TBM operator who then adjusted the TBM parameters accordingly. The baseline starting parameters were 1.5 bar of face pressure, cutterhead speed of 1.3 RPM and TBM advance rate of 15mm/minute. The copy cutter was deployed from face positions 10 o'clock to 4 o'clock and set to overcut 50 mm. These parameters were then refined over 30 meters of boring. When the TBM stopped after completion of ring No. 70 to install the gantries the face pressure had been reduced to 1.4 bar, cutterhead speed was 1.2 RPM and TBM advance rate was maintained at 15mm/minute. The copy cutter was being deployed from the 9 o'clock position through to the 5 o'clock position and overcutting 50 mm. Pumping of bentonite through the cutterhead and around the profile of the shields had also been introduced to reduce frictional forces between the TBM shields and ground. The results of the fine tuning of the parameters can be seen in Figure 8. The maximum heave above the machine was 3 mm, and the maximum heave/settlement for the preceding seven rings was restricted to 1 mm.
