# High Cover TBM Tunneling in the Andes Mountains— A Comparative Study of Two Challenging Tunnel Projects in Chile

**Carlos Lang** ▪ The Robbins Company  
**Mark Belli** ▪ The Robbins Company  
**Pablo Salazar** ▪ The Robbins Company

## ABSTRACT

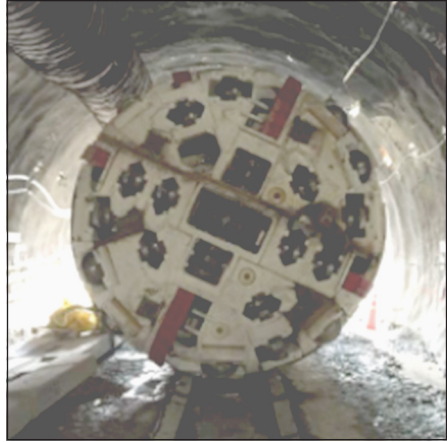
**Figure 2. Robbins first open gripper type Main Beam TBM inside El Volcán Tunnel**

In January 2015 Robbins supplied a 4.13 m open gripper type hard rock TBM with back-up System and a Robbins Continuous Conveyor System for muck transport along the bored tunnel to the portal area (see Figure 2).

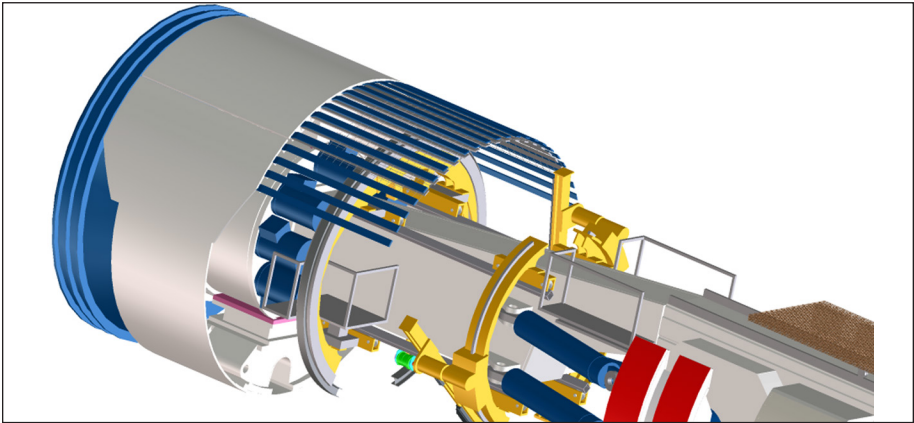
Figure 3. L1-working section ground support

For primary rock support in the so-called L1 section, extending from the rear end of the support shields to the level of the TBM gripper assembly, two roof drills were provided as well as one probe drill, a ring beam erector, work platforms and stands and shotcrete application (see Figure 3).

The two (2) roof drills were assembled on a ring shaped support structure to allow for rock bolting service at the tunnel wall and at 106° on either side from the top crown position.

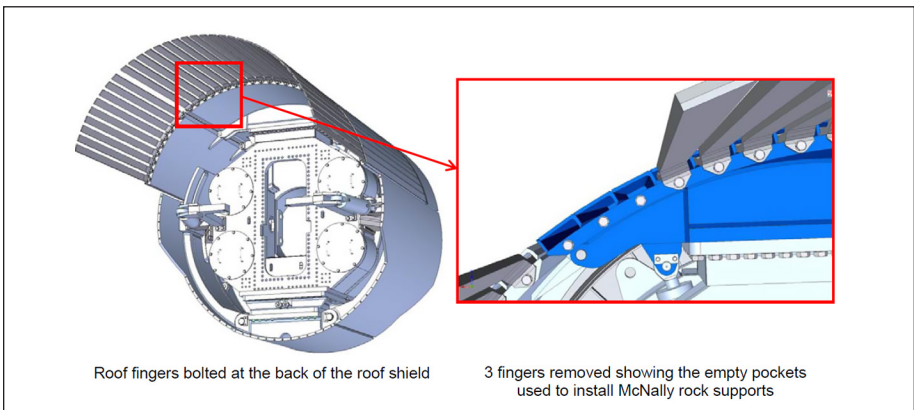
Figure 4. Finger shield removal and McNally System installation

As shown in Figure 4 and in lieu of the above traditional “finger shield,” the roof shield was designed to incorporate the Robbins-McNally “slat type” ground support system. The roof shield featured 35 roof “fingers” to protect the workers from rock falling in the TBM area. Each finger was installed in a pocket made of a structural angle bar and could be totally or partially removed when McNally rock supports were needed. The free pockets could then be used to install slats or rebar as needed for the McNally system.

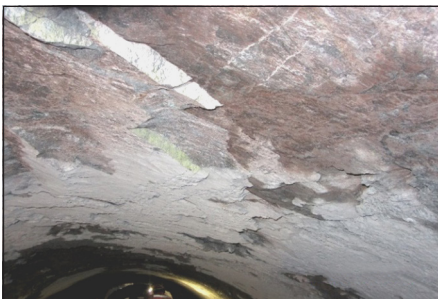
Figure 5. Planar roof and sub-horizontal joints

The Robbins TBM-1 started to bore on 15th June 2015, and during the first 15 days the TBM advanced 106.33 m along the tunnel. Rock mass presented good to fair quality with RMR values between 50 and 58 in the first meters of excavation with the TBM. Rock mass was composed of andesitic breccias with signs of alteration. The crown area was more fractured and it was observed that there were sub-horizontal joints that generated wedges and planar roofs.

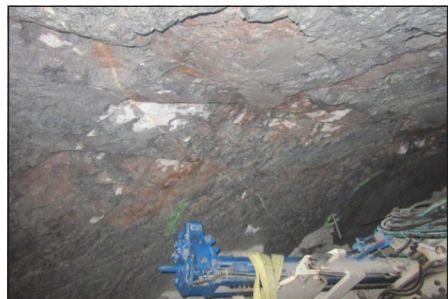
Figure 6. RMR=51

During tunnel boring the most commonly anticipated support type was *rock support type I*, consisting of welded wire mesh and resin end-anchored rock bolts 2.4 m long and 22 mm in diameter, positioned to  $\pm 60^\circ$  and  $\pm 25^\circ$  at 2 m intervals. Less commonly used would be *rock support type II*, consisting of 7 cm of shotcrete, welded wire mesh and resin end-anchored rock bolts positioned to  $\pm 60^\circ$  and  $\pm 25^\circ$  at 2 m intervals. *Rock support type III* would consist of resin end-anchored rock bolts 2.4 to 3.9 m long and 22 mm in diameter, positioned to  $\pm 60^\circ$  and  $\pm 25^\circ$  as well as spot bolts at  $0^\circ$  every 1 m, along with welded wire mesh and 10 cm of plain shotcrete distributed through  $165^\circ$  at the crown. Figures 5 and 6 show the rock mass in a stretch with rock class II with sub-horizontal joints and RMR=51.

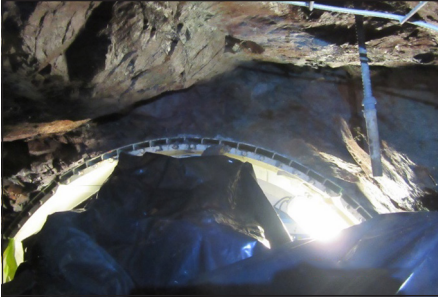
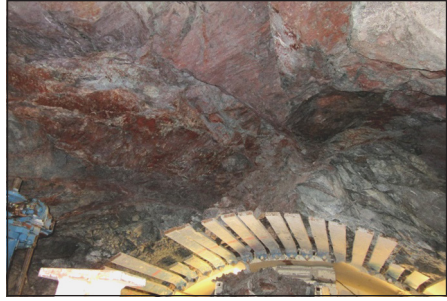
Figure 7. Sub-horizontal joints, RMR=42

Figure 8. 15 July 2015, support type III

Figures 7 and 8 show the support increased to type III when rock mass became worse (RMR approx. 40), due to two sub-horizontal joint systems at the roof that generated significant over-break.

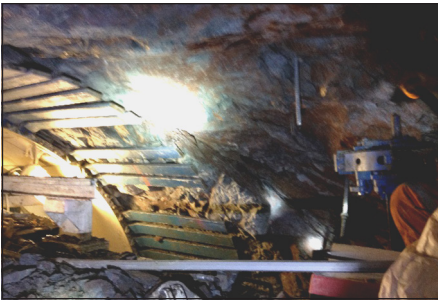
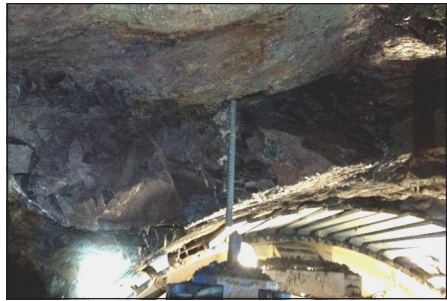
Figure 9. TBM excavation, overbreak with RMR = 32

Figure 10. TBM excavation, overbreak with RMR = 32

Figures 9 and 10 show intense scaling after each TBM stroke when the rock mass continued getting worse, with more fractures detected and RMR ranging from 32 to 34. Three joints/faults systems were detected—two sub-horizontals and one vertical in the crown—that caused continuous over-break.

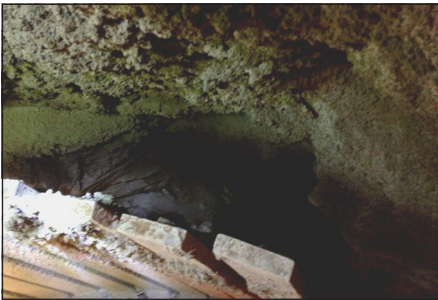
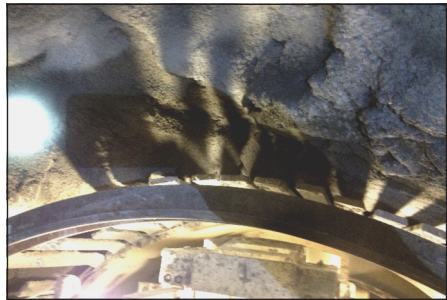
Figure 11. Ch. 13+862.31 and Ch. 13+861.50, support type IV

Figure 12. Ch. 13+862.31 and Ch. 13+861.50, support type IV

At a certain point, *support type IV* was required (Figures 11 and 12), which required yielding steel set installation due to the presence of a sub-horizontal fault/joint (dipping slightly upwards).

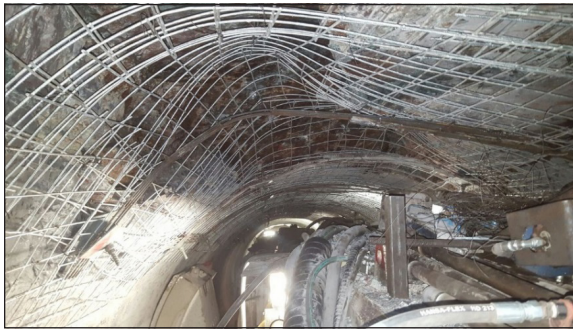
Figure 13. 8th December 2015, McNally System as additional support due to material detachment

On 8th December 2015 a 3 m long material detachment between the L1 and L2 area of the TBM was detected and loose material fell into the mesh, making it necessary to strengthen the support. The use of McNally elements as steel straps placed between rock bolts installed transversally and longitudinally around the affected area was instructed by the geologists, despite this support type not being part of the approved initial support design (see Figure 13).

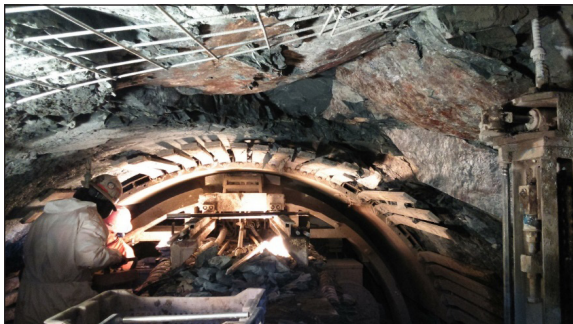
Figure 14. Advance 14th December 2015, Ch13+293

Figure 14 shows the right wall and crown highly fractured with support type III installed.

McNally slats were installed in the top 150° with steel arches as well as 5 cm of plain shotcrete distributed in 150° at the crown as a result of the rock mass quality steadily worsening with highly fractured rock and a lot of material falling during excavation.

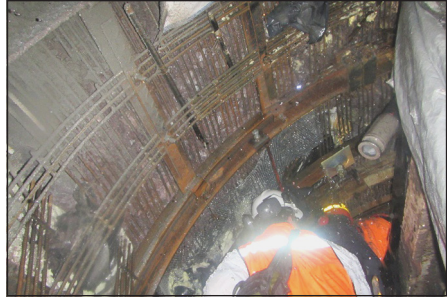
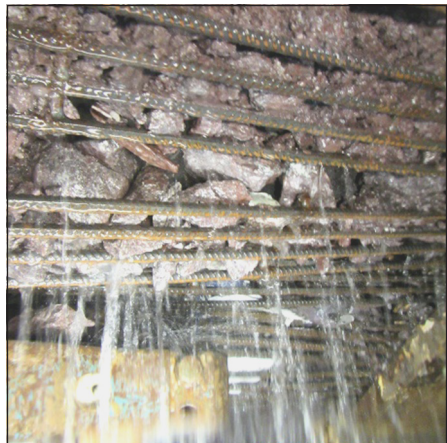
Figure 15. Initial support including McNally slats and water inflow conditions

Figure 16. Initial support including McNally slats and water inflow conditions

In order to control the area, chemical grouting was required to fill the cavities produced by the combination of clay infillings and water inflow. This chemical grouting was carried out during the 14th to 24th of January 2016 (see Figures 15 and 16).

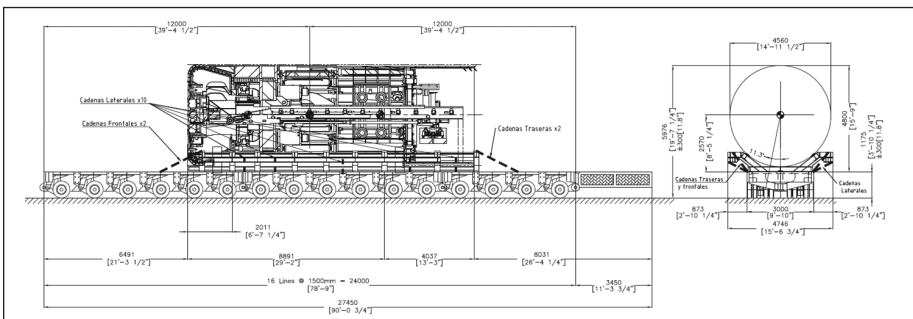
Figure 17. Mammoet heavy lift 16 axle hydraulic modular motorized trailer used to transport the TBM up to the tunnel launching chamber in Los Condores project

TBM site assembly started in mid-October 2015 onto a steel cradle provided by Ferrovial at “Plataforma Lo Aguirre,” a common laydown area for muck discharge and logistics for the two tunnels. Two months later, on January 2015, the TBM assembled onto the steel cradle was lifted and loaded onto a MAMMOET 27 m long x 3 m wide heavy lift 16-axle hydraulic modular motorized trailer specially designed for transport operations with heavy loads requiring a high bending moment (see Figure 17).

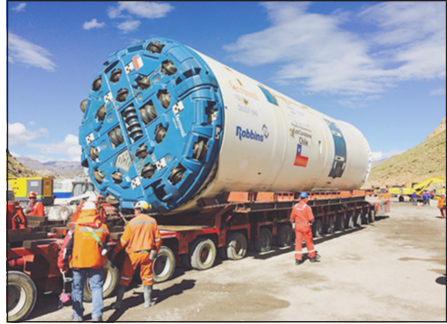
**Figure 18. TBM being moved into launching chamber**

In a second step the entire assembly was transported through the 1,0 km long pre-excavated Drill & Blasting (D&B) access tunnel up to the launching chamber. Lashing material to prevent sliding and/or tipping of the load was used to secure the TBM and cradle onto Mammoet trailer as well as anti-slip material between all steel contact areas to promote friction (see Figure 18).

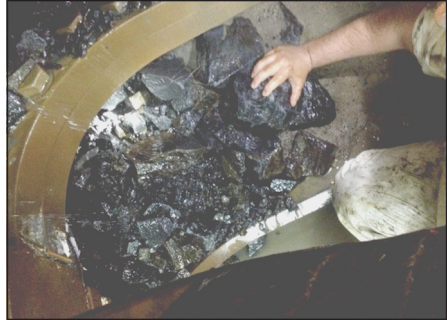
**Figure 19. Blocky material (andesite with fine sand from weathered rhyolite) inside the cutterhead**

Mixed ground conditions with very hard andesite (up to 150–200 MPa) on one side of the tunnel face and a very fine hydrothermal sand deposit from rhyolite on the other side were encountered. Combine this with a larger than normal rotatory unit to accommodate the many cutterhead ports, and the reduced capacity muck chute is what contributed to the failure and forced the TBM to stop for three weeks until a new muck chute was provided and installed.

This issue typically occurs in blocky ground when a boulder becomes caught between the muck chute and the rotating cutterhead. When the muck chute becomes blocked, the rock and material will usually overspill the chute. However a blockage can also occur in sticky clays or loose material (sand), especially when the muck chute spoil window is not big and the impact pad is not steep enough for fine material.

The real issue to overcome is to prevent boulders from getting caught between the cutterhead and muck chute. The operator must be aware of the ground conditions and the chance of boulders entering the cutterhead, and capable of recognizing the sign of a boulder getting caught (basically a large jolt of the machine as the boulder gets caught between the muck chute and the cutterhead). The operator must then stop the cutterhead as soon as possible to prevent it from being sheared off (see Figure 19).
