Rescuing and rebuilding TBMs in adverse ground conditions

ABSTRACT: Modern TBMs deliver high performance with availability rates that are beyond 90%. The TBM design concepts make the machines highly versatile for employment in varying soil and ground conditions. Machines can now withstand extreme loads and impacts in rough underground environments because of the components made for longtime use. Regular maintenance and planned service is the vital element in prolonging a machine's life and for high performance and availability. A well-serviced machine provides excellent performance as well as active project safety. Proper operation in variable conditions is also key. For instance, a hard rock TBM may run into zones of swelling rock. The most appropriate method to overcoming the swelling rock is to keep going, avoiding any unnecessary stops. Worn disc cutters that have not been maintained in due course are a prominent example of such avoidable stops, which may result in long downtimes and severe damage to the machine. However with modern and advanced techniques to underground tunneling, rescuing and rebuilding TBMs is possible to save the project. This paper will discuss methods an

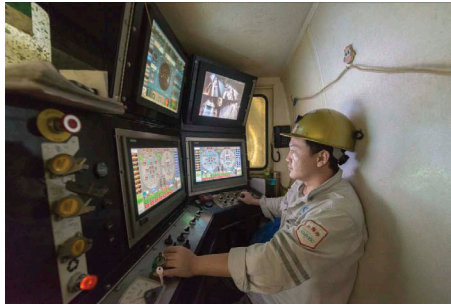
Figure 2. TBM data screens in operator's cabin.

Data reading and logging systems provide operators further clues as to when maintenance is required. Real-time data loggers can transmit to the surface where crew members can interpret the data, or the data can even be stored on a website where the TBM supplier can monitor the machine’s behavior and consult the crew. An example of this would be a high pressure reading at the main thrust rams combined with low torque at the cutterhead—this can be an

indication of worn gauge disc cutters that in conditions like swelling rock could result in the machine becoming jammed (see Figure 2).

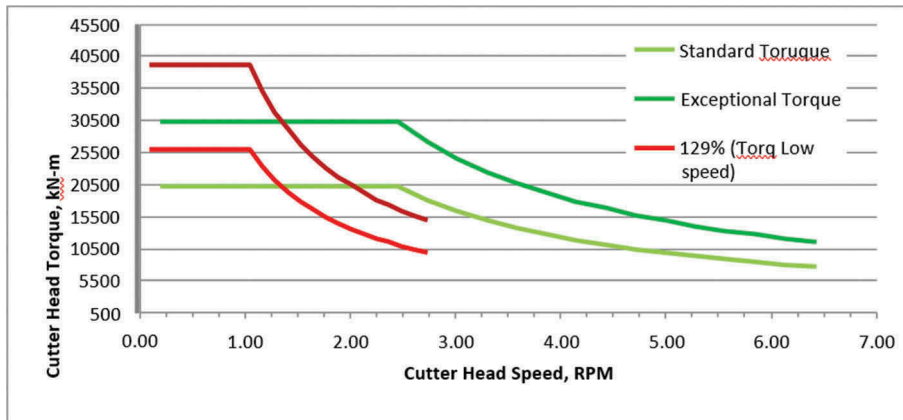
Figure 5. Cutterhead torque curves after modification.

To further mitigate the effects of squeezing ground or collapses, custom-made gear reducers were ordered and retrofitted to the cutterhead motors. They were installed between the drive motor and the primary two-stage planetary gearboxes. During standard boring operations, the gear reducers operate at a ratio of 1:1, offering no additional reduction and allowing the cutterhead to reach design speeds for hard rock boring. When the machine encounters loose or squeezing ground the reducers are engaged, which results in a reduction in cutterhead

speed but the available torque is increased. Figure 5 shows the torque curves for both standard and reduced gearing. After the installation of the canopy drill and the increase in available cutterhead torque, the TBM traversed several sections of adverse geology including stretches of severe convergence without becoming trapped.

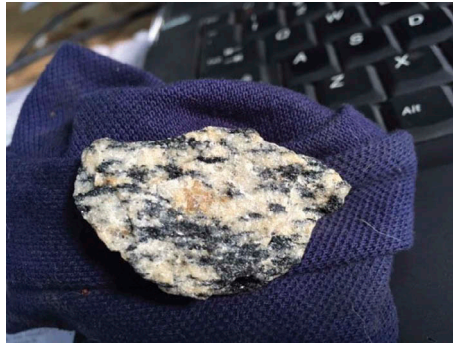
Figure 6. Rock sample taken from the face.

The Namma Metro Phase 1 Project in the Indian City of Bangalore included dozens of TBMs, many operating in mixed face conditions. One of the sections—a 1.0 km drive from Mantri Square to the central hub station of Majestic Gowda, as part of the North-South Corridor—utilized a 6.23 m diameter European-manufactured EPB. The TBM employed experienced severe wear at the cutterhead with the result that the TBM could no longer excavate a tunnel of sufficient diameter for the shield to pass through. In general, the TBM excavated in weathered granite having approximate compressive strength of 130 MPa with a high content of quartz and feldspars (see Figure 6).

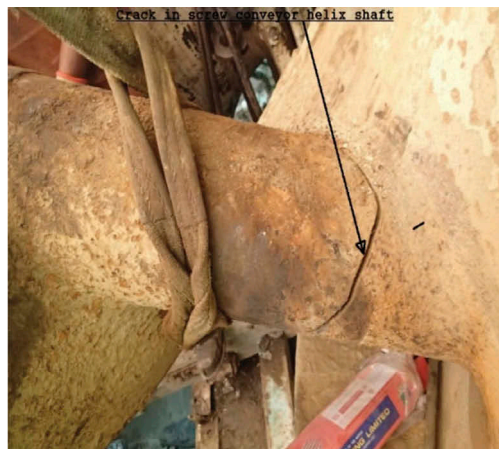
Figure 7. Extreme wear of helix measured at 230 mm to inside of casing & cracks at screw helix shaft.

The plan was to inspect the cutterhead and drive systems once the shaft was finished and the front of the machine could be accessed. Other components such as the screw conveyor were removed inside the tunnel for subsequent replacement with a combination of new and refurbished parts (see Figure 7).

Full refurbishment began in January 2015 with a programme of dismantling components such as the screw conveyor, hydraulic system, PLC, and checking the main drive. These actions uncovered even further signs of damage than earlier seen. A completely new drive system for the screw conveyor as well as the top helix section of the screw was ordered from Italy. The refurbishment was completed and re-commissioning began in August 2015.

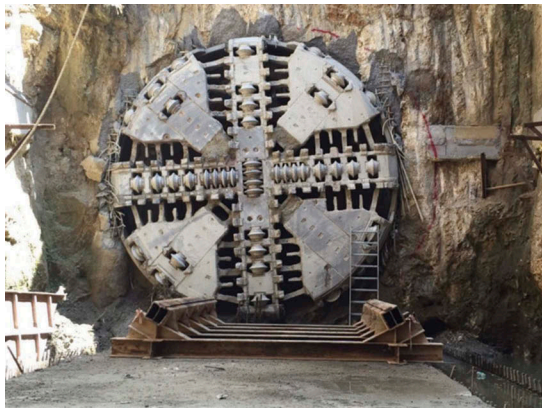
Figure 9. Condition of the new cutterhead after breakthrough into the final receiving shaft.

seal failure—filling the hubs with an oil/grease mixture helped overcome this problem. However, a disciplined programme of proactive service and maintenance kept the machine in good shape and at high availability. The service company in charge of the machine’s repair actively supported the contractor on site, demonstrating that even in the worst cases when machines are heavily damaged and have suffered extreme wear, they can be rescued and repaired in-situ (see Figure 9).
