Overcoming extreme tunneling conditions on Vietnam’s longest tunnel

S. Log, B. Li & P.N. Madhan
The Robbins Company, USA

ABSTRACT: Vietnam’s Thuong Kon Tum Hydroelectric project is a 17.4 km headrace tunnel that will be the country’s longest once complete. A section of the tunnel was excavated by a 4.5 m diameter Main Beam TBM in granitic rock up to 250 MPa UCS. Started in 2012, the project’s original contractor left due to non-satisfactory performance. In 2016, the contract to refurbish the TBM and excavate the remaining 10.45 km of tunnel was awarded to a joint venture of Robbins and a local contractor. Robbins was fully responsible for the TBM operation, including supplying operational crews. The crew overcame massive granitic rock, fault zones gushing water at 600 l/s, and difficult conditions. In under two years, the TBM advanced from a standstill at 15 percent project completion to 85 percent complete. This paper will address the refurbishment of the TBM in the tunnel, the work to streamline operation, and challenges faced.

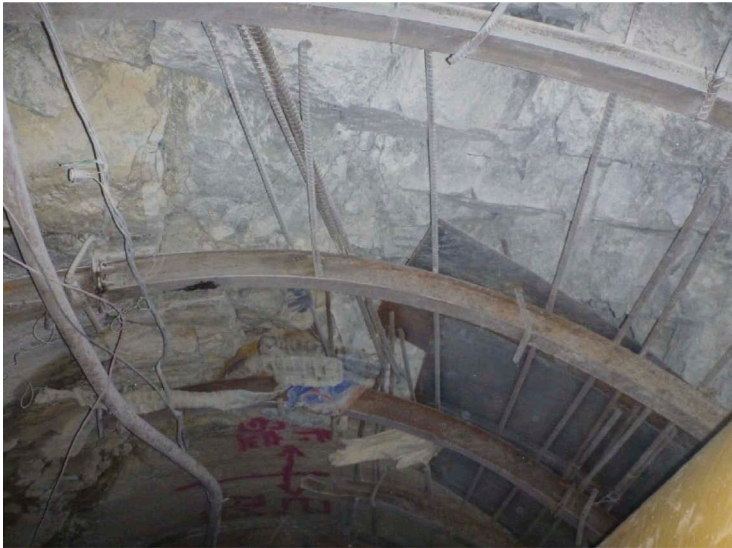
Figure 3. Example of inappropriate rock support.

In addition, there was a severe lack of appropriate rock support in the already excavated tunnel, which needed to be properly supported (see Figure 3).

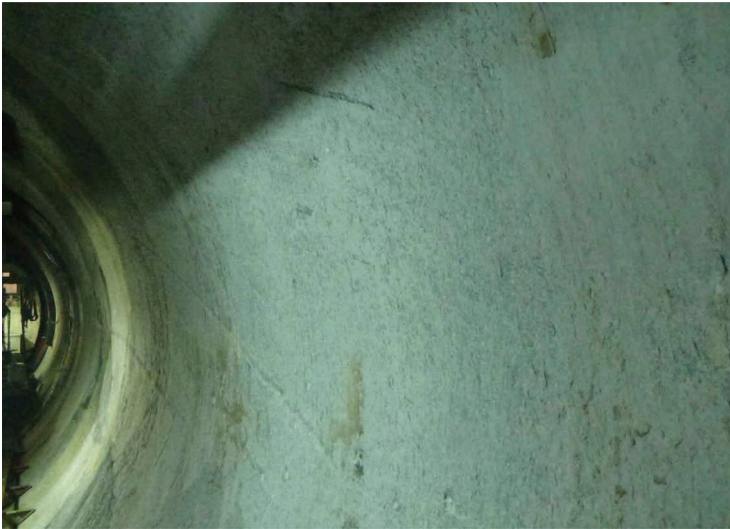
Figure 4. Example of typical rock conditions in the tunnel.

The encountered geology in the tunnel is a combination of granitic rock with a varying degree of gneiss features. The rock is generally massive with limited fractures, resulting in a high Q value and limited rock support needed. There are several stretches with practically no fissures and fractures. The rock is generally experienced as hard, but brittle (see Figure 4).

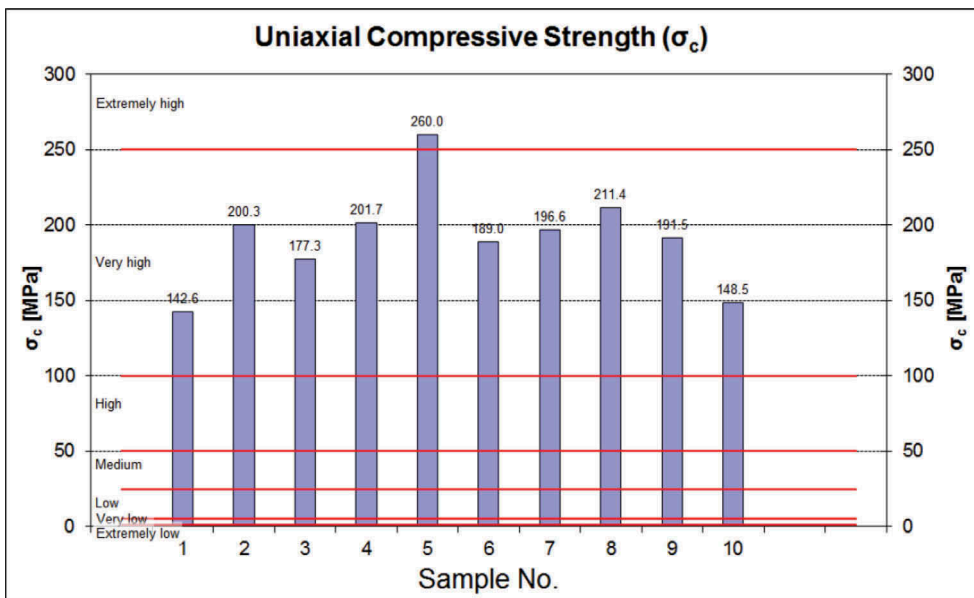
Figure 5. UCS values tested at international laboratory.

During operation, UCS testing of the rock was performed at representative locations in the tunnel. This was sent to an internationally recognized laboratory and the results can be seen in Figure 5 (Dahl, 2016).

The results from the testing show a very high rock strength in the majority of the rock mass with strengths of up to 260 MPa. The average rock strength is 194 MPa.

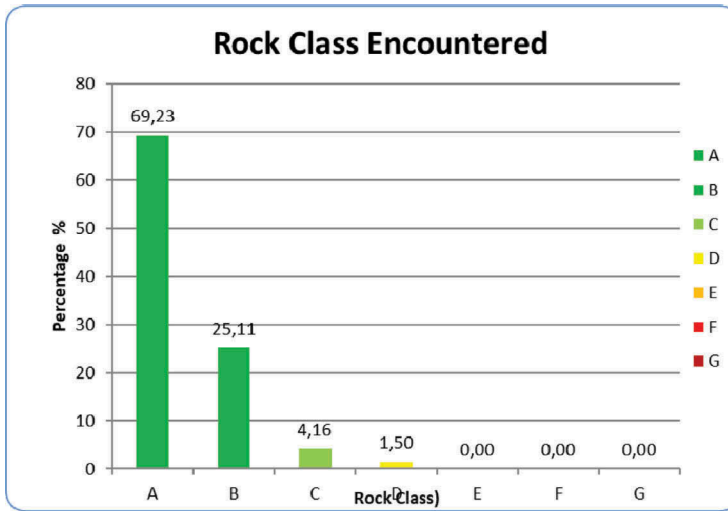
Figure 6. Rock class distribution as mapped by Robbins geologists.

a relative massive total water ingress in the tunnel over the length. The Q classes for a representative part of the tunnel are given in Figure 6.

The above charts show that the tunnel has been excavated in a very hard and massive granitic rock type, with more than 90 percent being in rock class A and B. This also gives a clear indication that the majority of the tunnel can be unsupported or supported only by spot bolting.

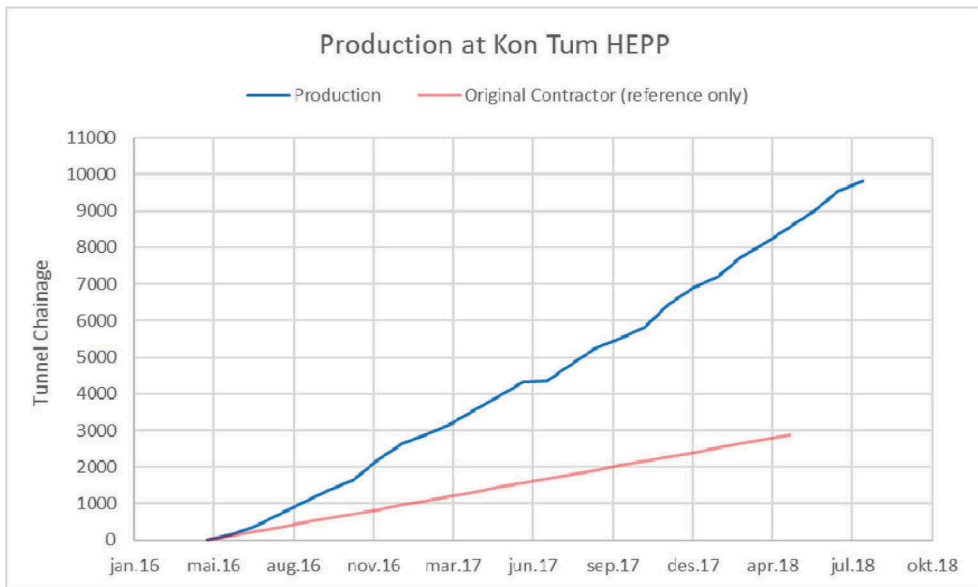
Figure 8. Production chart and comparison to production in 2012–2014.

The average production of the project after May 2016 until September 2018, with less than 500 m left to bore, has been about 380 m/month. This includes significant maintenance and advancing through adverse fault zones, which has required pre-excavation grouting. The steady production and vast improvement on the project is clearly visible in the production chart given in Figure 8.
