Completing Mexico City's Mixed Ground Mega Tunnel: Emisor Oriente

On May 23, 2019, the last of six 8.93 m diameter EPBs completed excavation at Mexico City's Túnel Emisor Oriente (TEO), a feat marking the completion of ten years and 62.1 km of tunneling. The TEO is a critically-designated plan to stem severe flooding while boosting wastewater capacity, and is the country's largest infrastructure project. The six EPB TBMs excavated some of the most complex geology on earth, ranging from abrasive volcanic rock to watery clays. This paper will cover the incredible challenges and solutions used to overcome what may be the toughest conditions ever bored by EPBs.

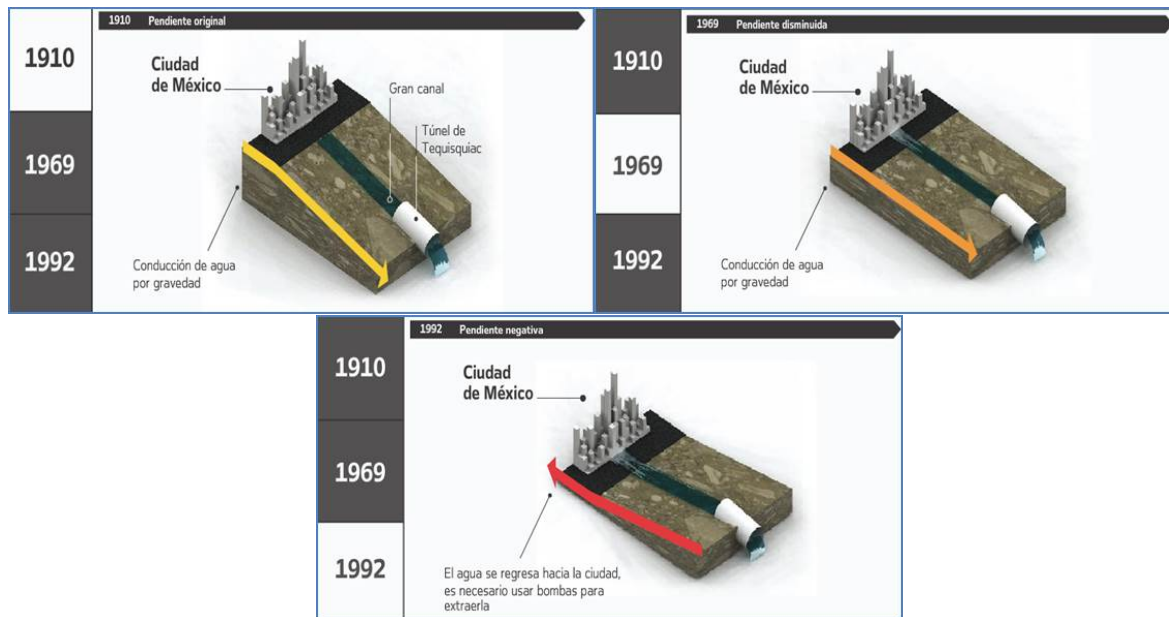
Figure 2. Change in slope of the Emisor Central between 1910 and 1992.

The idea of opening drainage canals first came about after a flood of the colonial city in 1555. The first canal, known as Nochistongo, was built in 1605 to drain the waters of Lake Zumpango north through Huehuetoca, which would also divert waters from the Cuautitlán River away from the lakes and toward the Tula River. Another canal, which would be dubbed the "Grand Canal" was built parallel to the Nochistongo, ending in Tequixquiac. The Grand Canal consists of one main canal, which measures 6.5 meters in diameter and 50 km long, and three secondary canals, built between 1856 and 1867. The canal was completed officially in 1894 although work continued thereafter. Despite the Grand Canal's drainage capacity, it did not solve the problem of flooding in the city. From the beginning of the 20th century, Mexico City began to sink rapidly and pumps needed to be installed in the Grand Canal, which before had drained the valley purely by gravity. Currently, and despite its age, the Grand Canal can still carry 42 m³/s out of the valley, but this is significantly less than what it could carry in late 1975, which was 80 m³/s. This decrease is due to the continued sinking of the city (by as much as seven meters), which weakens the system of water collectors and pumps (see Figure 2).

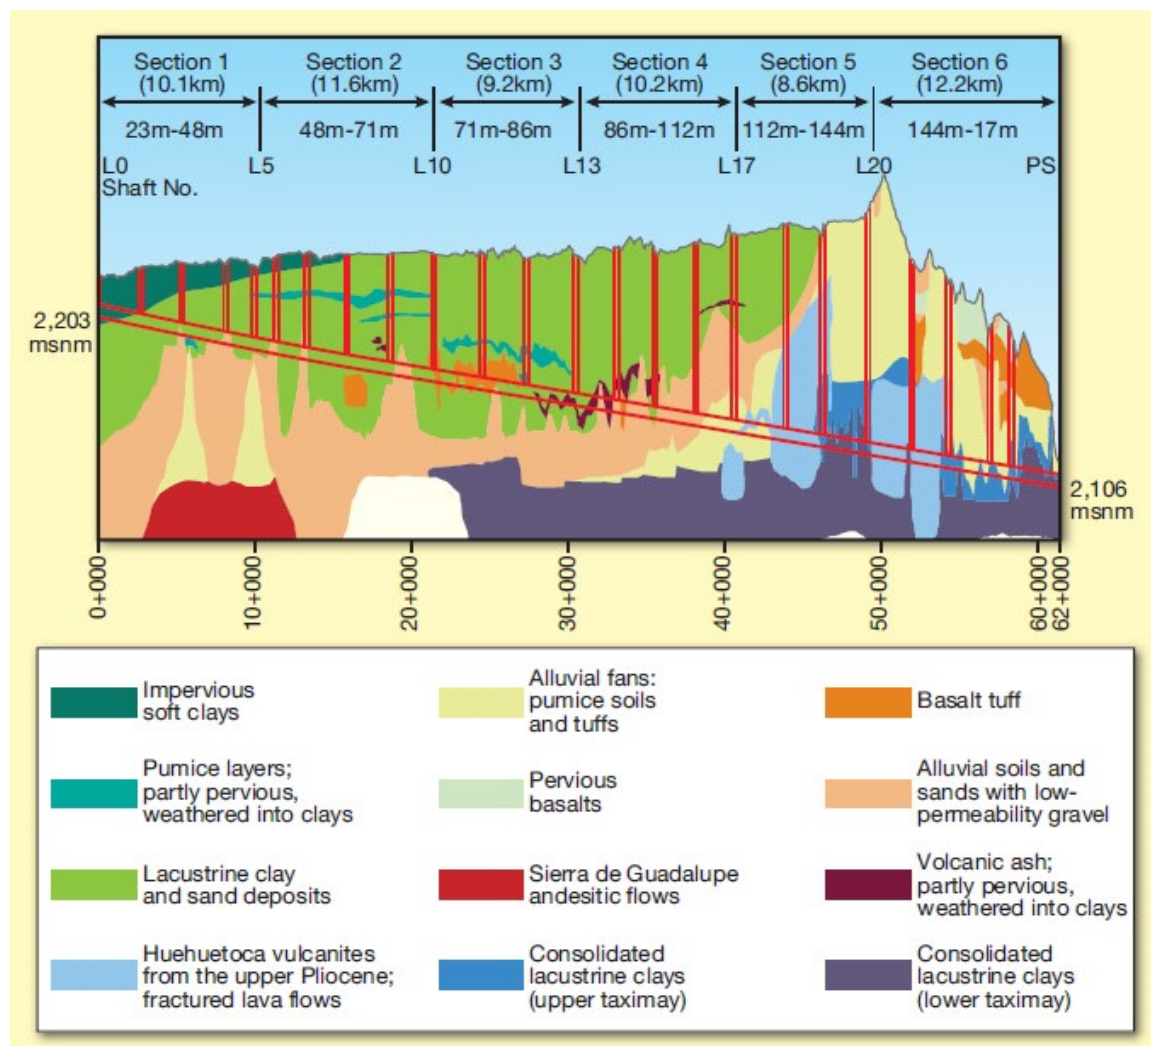
Figure 4. TEO geology. *Image Credit: Tunneling Journal North America.*

Originally geology was based on 64 borehole tests conducted along the tunnel length, as well as six cross tunnel locations that were considered (see Figure 4).

Lot 1: Quaternary lacustrine deposits of northern Mexico Basin.

Lot 2: Basaltic ashes and pumice, Quaternary strata, and northern flank lavas from Nochistongo.

Lot 3: Clay from the Pre-Quaternary lacustrine Basin of Mexico.

Lot 4: Fluvial Sands of the Plio-Quaternary Nochistongo Mountains.

Lot 5: Pliocene volcanic formations from the upper part of Huehuetoca.

Lot 6: Pliocene lacustrine deposits, Taximay medium and Taximay Superior.

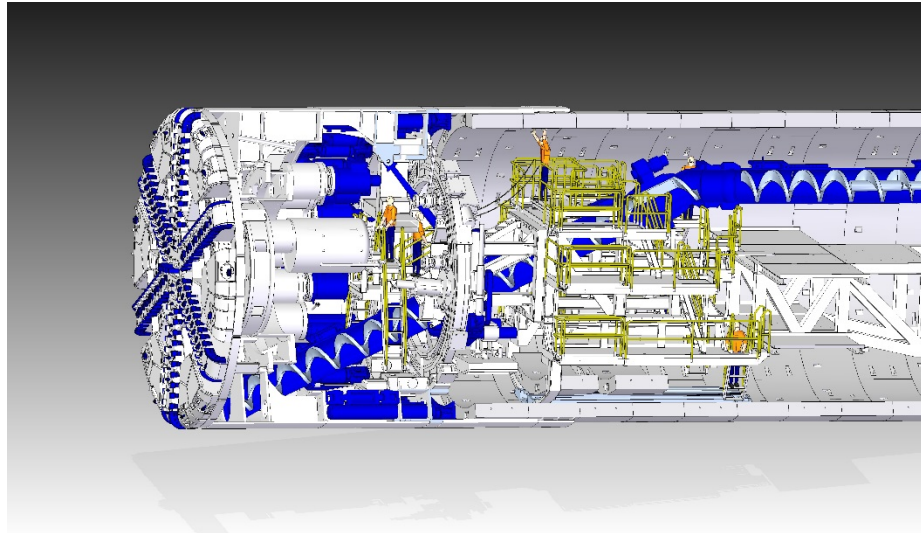
Figure 5. Original Machine Design.

The three Robbins machines (provided for lots 3, 4, and 5) were built for abrasive basalt sections up to 80 MPa UCS mixed with sections of watery clay that have been compared to a soup, with water pressure estimated in the range of 4 to 6 bar (see Figure 5).

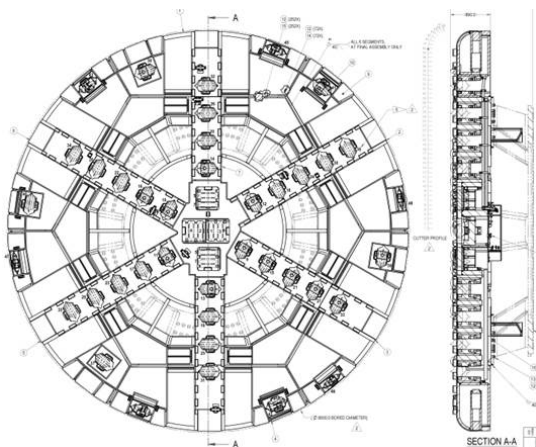
Figure 6. Hard Rock Cutterhead.

The custom designed EPBs were engineered with mixed ground, back-loading cutterheads to tackle variable conditions. High pressure, tungsten carbide knife bits could be interchanged with 17-inch diameter carbide disc cutters depending on the ground conditions. During tunneling a number of small shafts, spaced every 3 km between the larger launch shafts, were used to perform cutter inspection and changes, and to replace the tail seals. Specialized wear detection bits lost pressure at specified wear points to notify crews of a needed cutting tool change. The knife edge bits were arranged at several different heights to allow for effective excavation at various levels of wear.

Twenty-five injection ports spaced around the periphery of the machine could be used for injection of various additives depending on ground conditions and for probe drilling, with an additional six ports for the foam system. Additives such as Bentonite were used to condition the muck for removal by belt conveyor (see Figures 6-7).

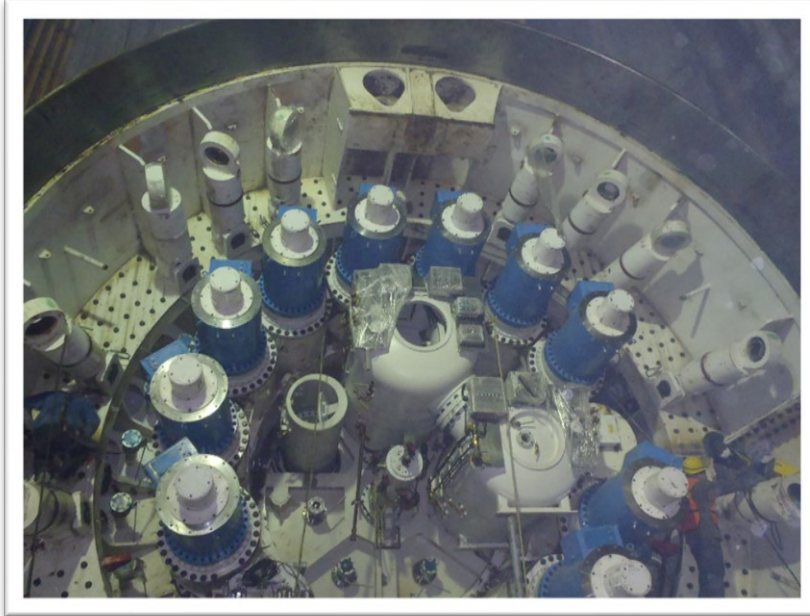
Figure 8. Man and Material Lock.

- A 7-bar man lock with an additional decompression chamber to allow two teams to work at the same time. Also, a material lock to be able to handle cutting tools more easily.

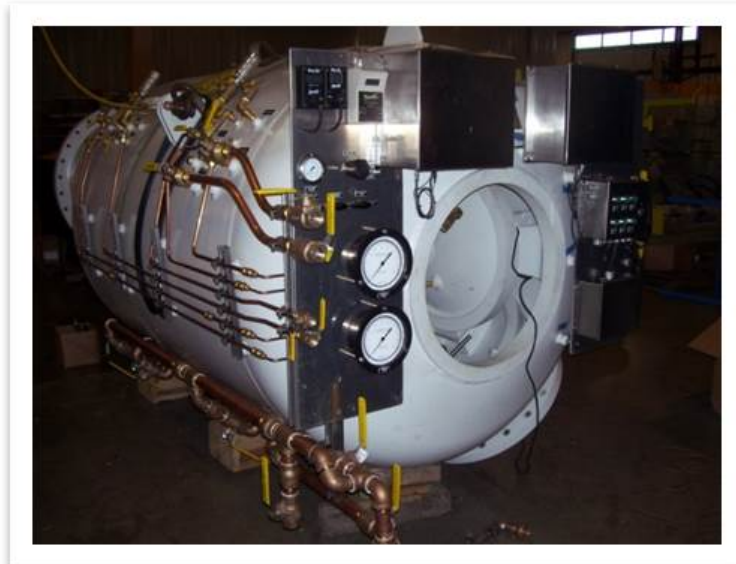
Figure 9. Man Lock for 7 bar pressure.

- A redesigned bulkhead to allow the new configuration of the man and material locks up to 7 bars and high pressure in the tunnel.
- Chromium carbide plates to reinforce the screw conveyor and removable wear plates added to each turn of the screw conveyor in order to withstand abrasive hard rock. The screw conveyor was also able to open up as a “coffin” to be able to check for wear and plates replacement.

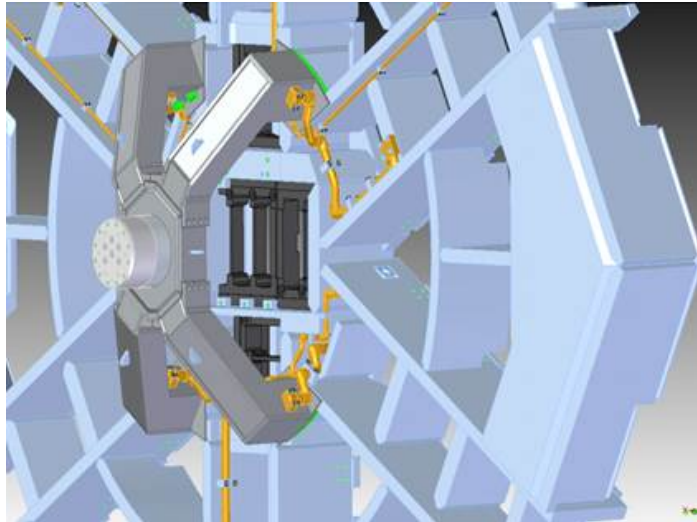
Figure 10. New Design of Rotary Union.

- New design of the rotary union joint that improved the time to change the center disc cutters.
- New design of scrapers capable of resisting load impact in mixed ground conditions in the presence of hard rock.

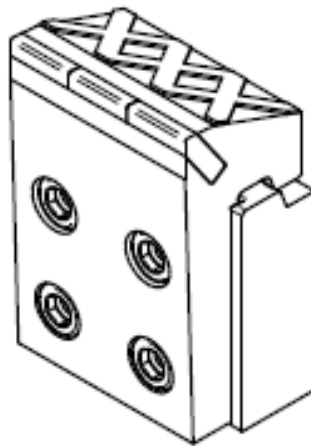
Figure 11. New design of the face scraper.

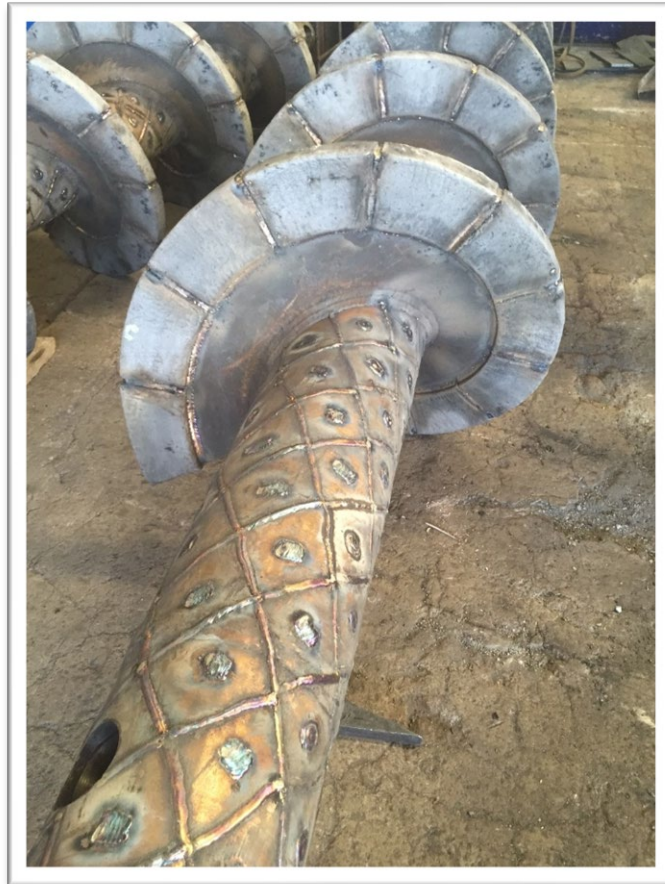
Figure 12. Screw Conveyor Helix Wear Protection plates.

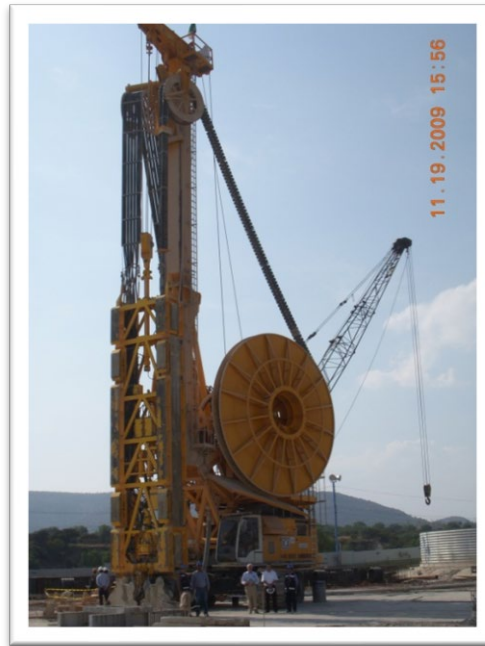
Figure 13. The hydro roadheader at shaft 20

One of the most important shafts constructed was shaft 20, as it is the deepest civil works shaft in Mexico, demanding extra attention to Lot 5. The construction of the shaft was quite unique, as the contractor utilized a hydroroadheader (see Figure 13) that was able to excavate panels or sections of the slurry wall or diaphragm walls up to 100 meters deep. After constructing the complete circumference of the shaft, the rest of the excavation was done by both the traditional shaft sinking method and the cut and cover method.

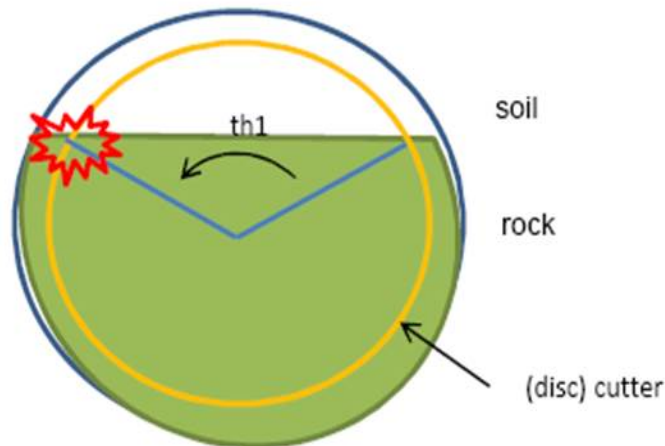
Figure 14. Diagram of impact loading.

The erratic rock fragments and andesite deposits created wear problems in the cutting discs, which required a strict program of several cutterhead inspections in order to inspect, change and analyze the wear issues that the tunnel was presenting. These wear issues were not expected in terms of the geologic complexity (see Figure 14).

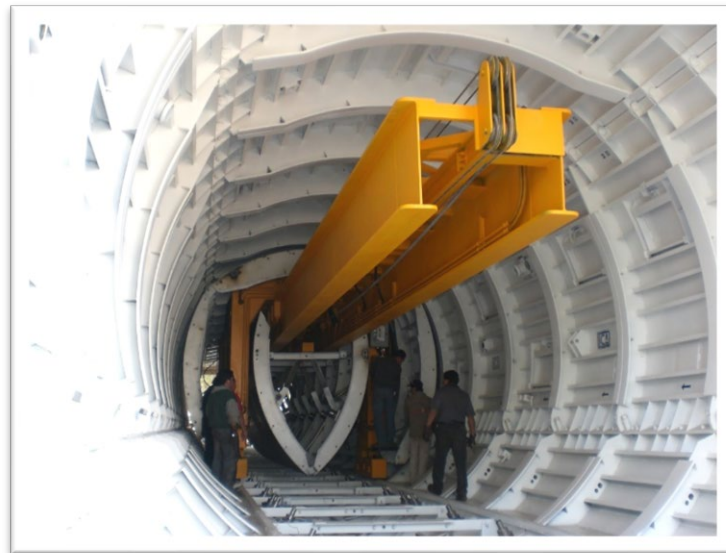
Figure 15. Cast-in-place form

The installation of cast in place secondary lining also was carried out with very good advance, thanks to the telescopic form that ensured a continuous cast tunnel slip form for installation of the 350 mm thickness concrete lining. The tunnel cast in place form had a length of 45 meters and achieved over 180 meters per week (see Figure 15).
