Record-Setting Tunnel Boring Below Lake Ontario at the Ashbridges Bay Outfall Tunnel

The 3.5 km long Ashbridges Bay Outfall in Toronto, Ontario, Canada was a challenging drive set below Lake Ontario. After a remote machine acceptance due to the global pandemic, an 8 m diameter Single Shield machine launched in March 2021 from an 85 m deep shaft and began its bore in shale with limestone, siltstone and sandstone. During excavation, the TBM and its crew bored a city-wide record of 30 rings in one day, or 47 m of advance. This paper will cover the unique project, from TBM acceptance through to launch, tunneling in difficult conditions, and completion in 2022.

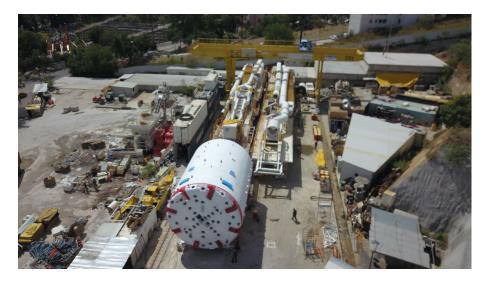
Figure 8. The Ashbridges TBM during the virtual machine acceptance in Mexico.

By the time the assembly team reached the factory acceptance testing phase, much of the world was on Covid lockdown and travel was restricted between the U.S., Canada, and Mexico where the teams were based. Because of this a virtual TBM factory acceptance test was performed online for the first time ever, where personnel walked through the machine while it was in Mexico and showed each component performing the required testing (see Figure 8).

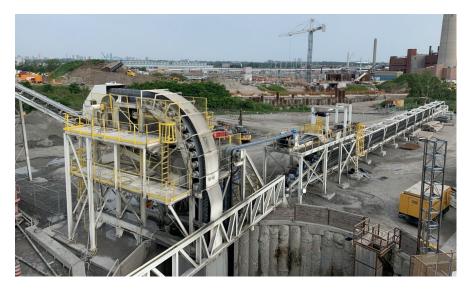
Figure 10. Project site at the surface with continuous conveyor configuration.

Robbins conveyor systems were supplied and included the 3.5km long tunnel conveyor, vertical conveyor installed in the shaft, and a stacker conveyor on the surface for muck storage and haulage—the system would need to move over 174,000 cubic meters of material to build the tunnel. A large grout plant was also

built at the surface to support the significant grouting operation behind the TBM tail shield while placing segments. Each ring required well over 5 cubic meters of grout material per ring (see Figure 10).

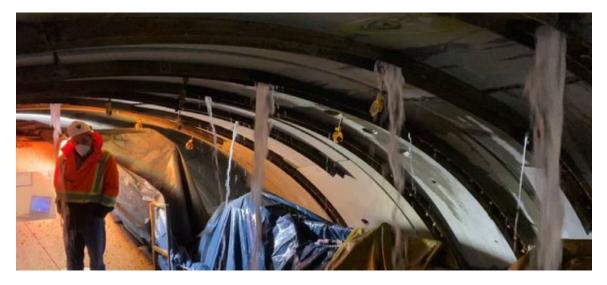
Figure 12. Significant, sustained water inflows from the rock formation above the tunnel crown (Solecki et. al., 2022).

About 2.5 km into the tunnel, the machine hit its first section of significant groundwater. This was followed by another section about 3.2 km in. Both sections had high enough water inflows (>400 lpm) to significantly damage the pre-cast concrete lining. In one instance a sustained water inflow in excess of 100 lpm was measured per hole (see Figure 12). The holes were left to drain and there was no evidence of reduced flow over a period of time. It was therefore contemplated that water inflows could have a direct connection to the lake above the tunnel alignment. At these locations, the ground conditions consisted of approximately 15m of GBSF rock cover above the tunnel and 35m of overburden deposits. The distance from tunnel springline to lake level was approximately 70m. In some holes, packers were installed to confirm groundwater pressures ranging between 1.7 to 3.1 Bar. When these conditions were first encountered, damage to the pre-cast concrete lining occurred in the crown of the tunnel consisting of structure cracks (>25mm in thickness) and movement to the rings (steps & lips).

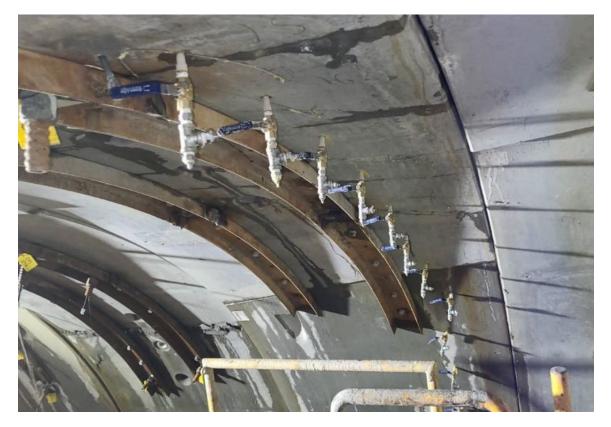
Figure 13. Chemical grout collar radial injection ports to stabilize ring along with steel channel.

- 1. Install a chemical grout collar (see Figure 13) around the first ring immediately outside the TBM shield. In total approximately 50-70 drill holes were installed around the complete ring, with approximately 2 to 4 liters of chemical grout injected per hole.
