# Lessons Learned During Excavation of the Incredibly Challenging Yin Han Ji Wei Water Diversion Tunnel

**ABSTRACT:** The 2022 breakthrough of an 8 m diameter Main Beam TBM at China's Yin Han Ji Wei project was a triumph of technology and perseverance – crews at the 17.5 km long tunnel encountered over 14,000 rock bursts, some with energy as high as 4,080 kJ. The rock, consisting of mainly quartzite and granite, was estimated to have a rock hardness of between 107 and 309 MPa UCS, with high abrasivity and a maximum quartz content of 92.6%. The incredibly challenging tunnel also experienced at times severe water inflows, with one particular event exceeding 20,000 m<sup>3</sup> of water in one day from a single point. In-tunnel ambient temperatures peaked at 40 degrees Celsius and 90% humidity. Throughout the challenges, the crew and support teams found ways to persevere – whether through unique ground support, or increased monitoring and analysis. In this paper, we will examine the successes and lessons learned in the incredibly challenging ground conditions, determining what worked best to confront each condition as it came up. Recommendations will be made towards what could be us

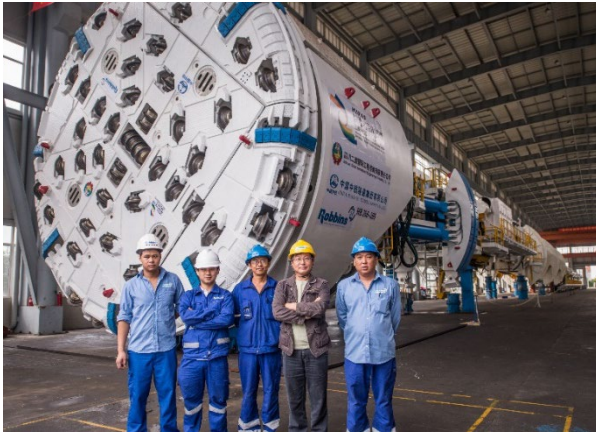
Figure 3. Yin Han Ji Wei TBM

The Main Beam TBM TBM was designed for hard rock, high stresses and high water inflows, with a predicted excavation progress rate of 480m/month (see Table 2 and Figure 3).

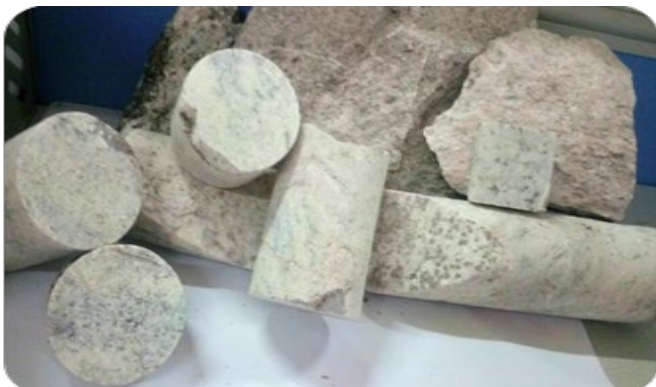
Figure 5. Quartz granitoid core samples analyzed.

In July 2018, Robbins invited an independent geological consultant to the jobsite. The consultant confirmed that from the mineral composite, rock of such rich quartz content should be better described as quartz granitoid. Granite normally has a quartz content of 25% to 30%. This quartz content at 60% to 90%, “is beyond that to be expected in granite, producing a very abrasive rock of high strength from the dominance of the bond between the abundant quartz crystals”, according to the report (see Figure 5).
