# Tunneling in Mixed Face Conditions: An Enduring Challenge for EPB TBM Excavation

Jim Clark • The Robbins Company Paul Verrall • Afcons

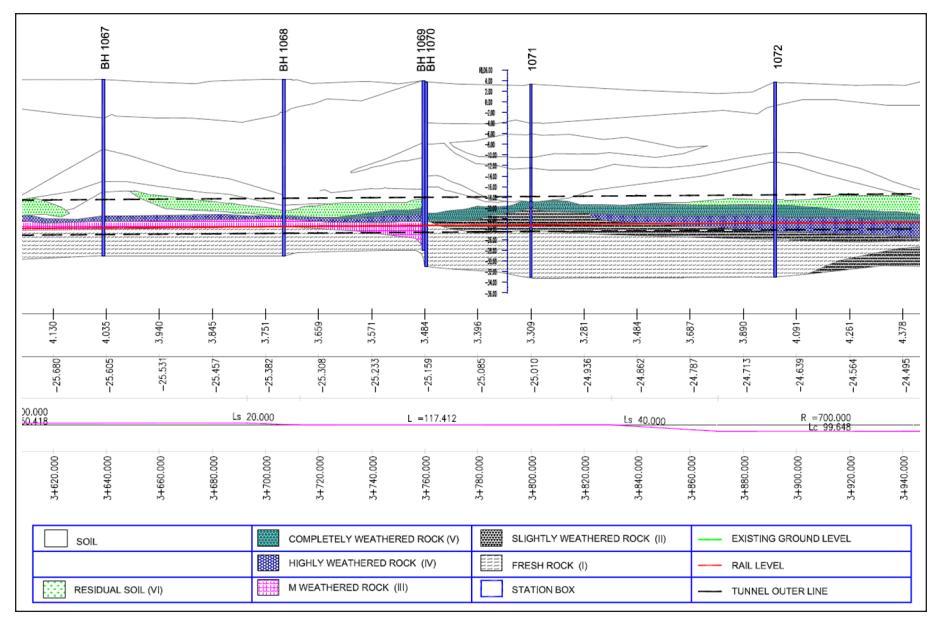
The entire area of the project is situated within a flood plain, with relatively minor deviations in surface levels. The geology along the alignment of the Chennai Central Station to Mayday Park station section is made up of dense silty sands interbedded with layers of clay and silt and granite with weathering grades varying from highly fractured and weathered (Grade V) to fresh rock (Grade I). The water table varies seasonally but remains above the tunnel alignment all year round. The overburden along the alignment ranged between approximately 11 meters and 16 meters (see Figure 1).

Figure 1. Geological section showing mixed face in the tunnel cross section

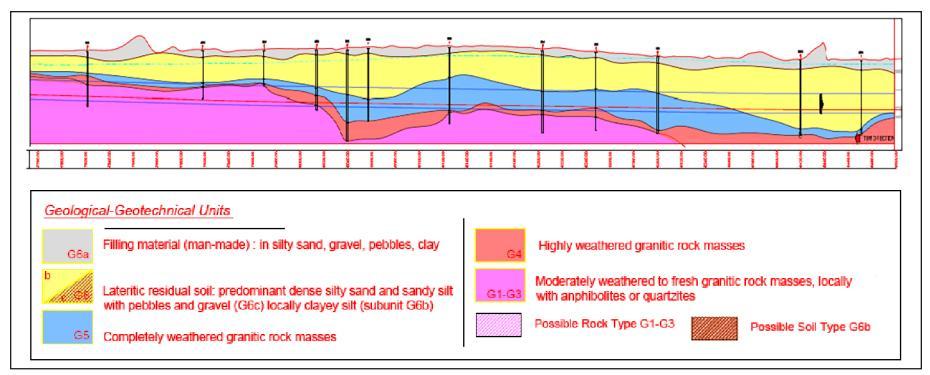
Figure 5. Geological cross section showing mixed face conditions

The geology between Chickpet and Majestic station is made up of fill material, residual soils, dense silty clay and varying grades of granite ranging from completely weathered through to fresh un-weathered rock. The piezometric level ranges from between 5 m to 10 m above the crown of the tunnel. The overburden along the alignment ranges from approximately 10–14 meters. Approximately 60% of the drives were expected to be driven through difficult mixed face conditions. In addition to the difficult geology the vast majority of the alignment ran beneath a densely populated area crammed with surface structures, many of which were poorly constructed. The geological long section can be seen in Figure 5.
