# **Rescue and Refurbishment of a TBM inundated with Flood Waters at the New York City Harbor Siphon Project**

Roger Cope, Field Service Technician, The Robbins Company

# ABSTRACT

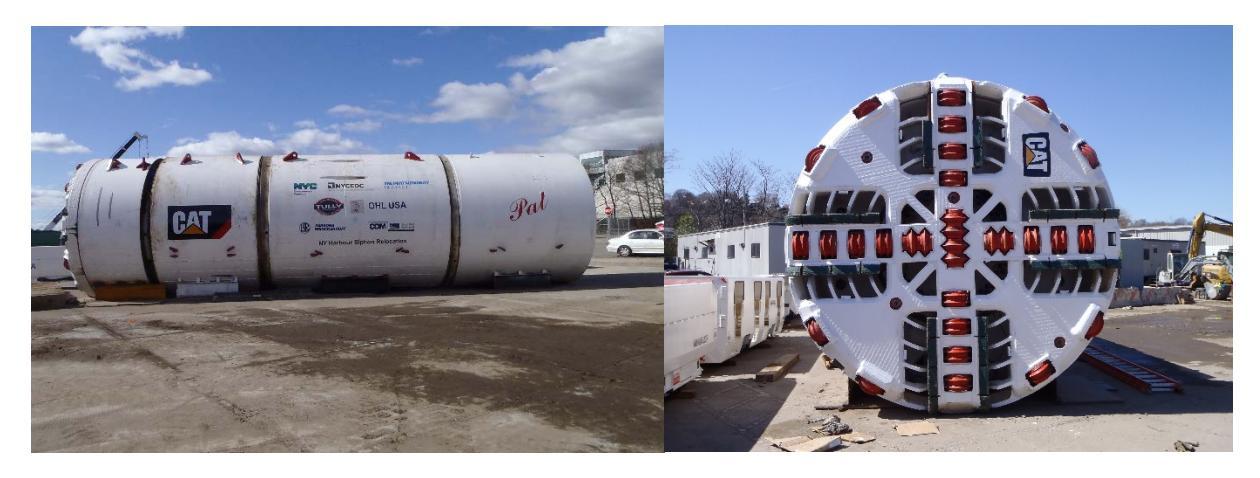
The tunnel subcontractor, Tully/OHL USA JV, procured a 3.6 m diameter EPB TBM from Caterpillar in 2012. The TBM, dubbed "Pat", was designed to drive through highly variable clays and sands under full hydrostatic conditions. The machine was designed specifically for the difficult undersea drive and to withstand potential hydrostatic pressures of up to 8 bar. It was launched from the 35 m deep, 8.5 m i.d. Staten Island shaft to drive toward the 24.3 m deep, 7.3 m i.d. Brooklyn shaft. The contractor anticipated average advance rates of 17 m per day (see Figures 2-3).

Figure 2. Side view of CAT TBM.

Figure 3. CAT TBM Cutterhead.

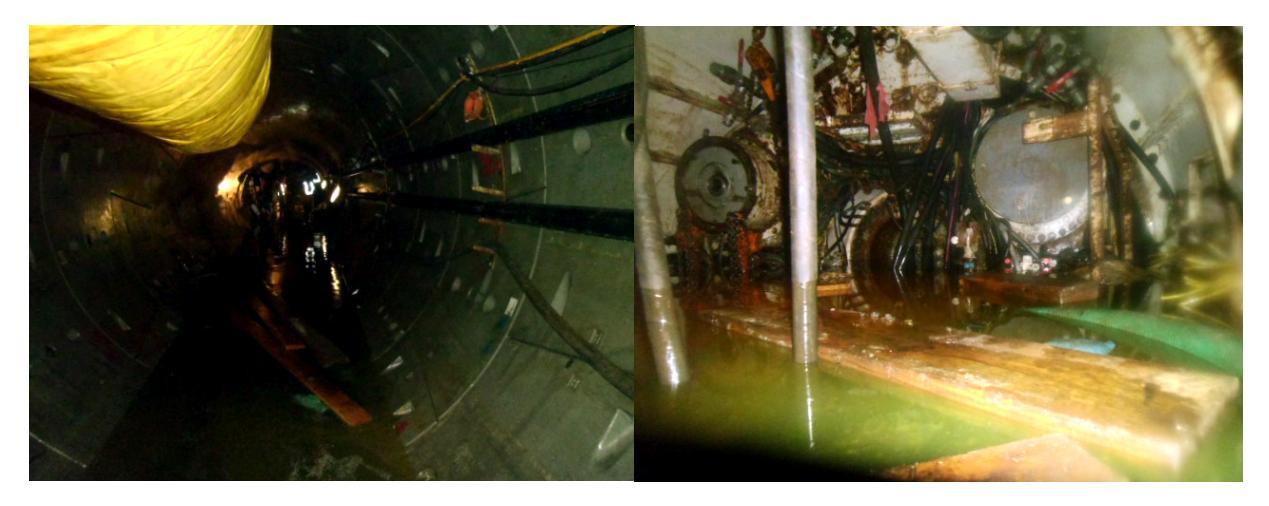
Unfortunately, a major setback was dealt to the owners of the Siphons project and Tully/OHL USA JV when in late October 2012, Superstorm Sandy brought flood waters to New York City and hurricane force winds of 145 kph. On October 29<sup>th</sup>, Superstorm Sandy drove water levels at the Staten Island site to three feet above the one hundred year flood level. The protective concrete barriers around the shaft and sandbags at the mouth of the tunnel were overcome and the nearly 113 m long machine was entirely submerged under sea water after boring only 460 m (see Figures 4-5).

Figure 4. Tunnel after the flood.

Figure 5. Inside the TBM, looking forward at the drive motors and man lock, partially submerged.

Following the storm, water was pumped from the TBM and crews were sent into the tunnel to perform essential maintenance. Workers representing the New York City's Local 147 laborers union (affectionately referred to as 'sandhogs') and mechanics from local 15 IOUE under the direction of Tully/OHL USA management protected critical bearing components by ensuring that the bearing cavity was fully immersed in clean oil. The machine then sat idle until late July 2013 when TBM manufacturers were contacted for proposals to refurbish the machine so work on the project could continue (see Figure 6).

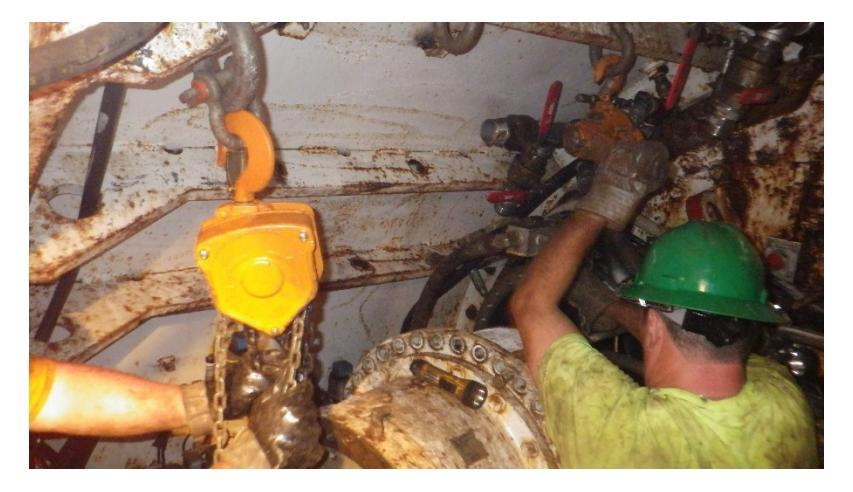
Figure 6. The Crew Inspect Gearboxes on the stranded TBM.

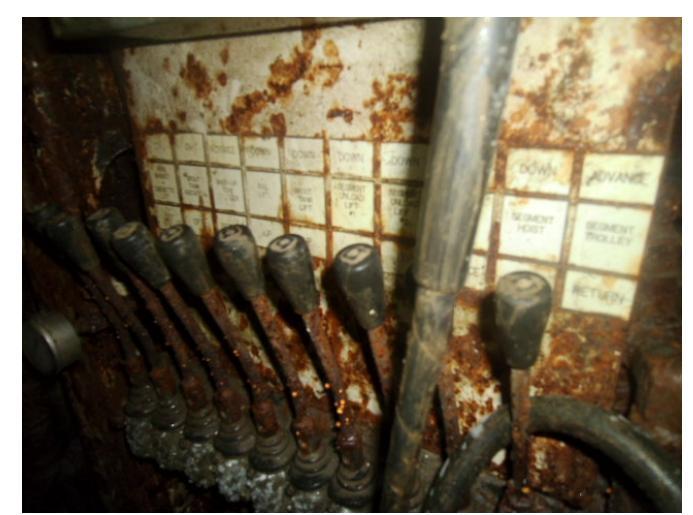
Figure 7. Example of salt water corrosion – segment unloader controls.

Among the prospective candidates for TBM refurbishment were Herrenknecht of Germany, Caterpillar (CAT) Tunnelling Company of Canada, who manufactured the TBM, and the Robbins Company based in Solon, Ohio. Robbins travelled to Staten Island in late July 2013 and performed a comprehensive survey of the heavily corroded machine, which had been extensively damaged by salt water, and prepared a detailed proposal (see Figure 7). The proposal provided detailed descriptions of the scope of work and included a clause establishing a bonus or penalty condition for the completion of the refurbishment in mid-December

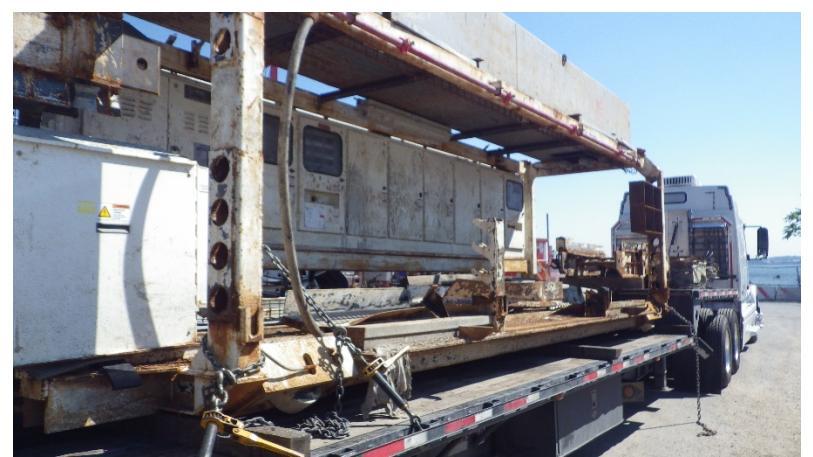
Figure 8. Back-up system being shipped to Solon, Ohio.

The general plan for the refurbishment centered on removing the rear eleven gantries and belt conveyor from the tunnel and shipping them by truck to Robbins' Solon facility where the backup gear could be completely cleaned, evaluated and repaired (see Figures 8-9). The remaining two gantries, screw conveyor, segment erector, stationary shield and forward shield would have to be refurbished onsite in the tunnel. The segmented concrete tunnel lining would not permit the removal of these items.

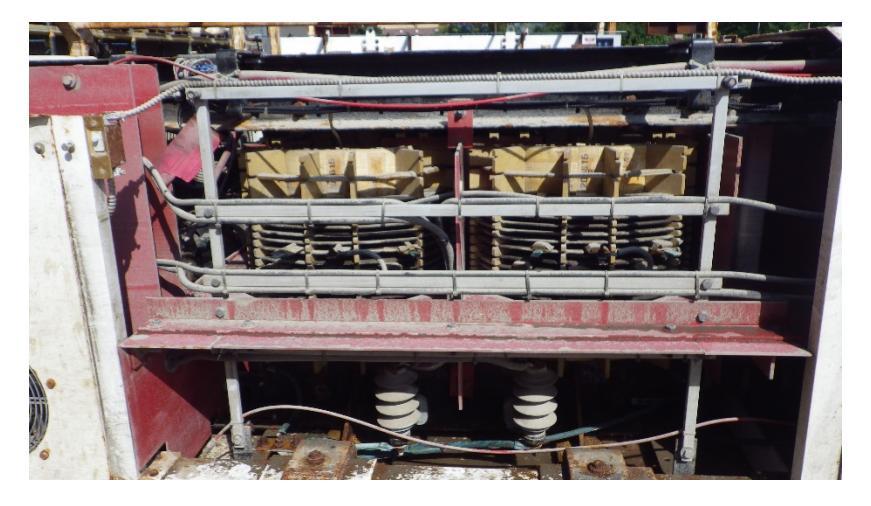
Figure 9. Substation rework in Solon, Ohio.

The parties involved set about immediately on a two-pronged approach of shipping the removed equipment to Solon, and organizing a plan for the onsite refurbishment of the remaining items. By early August, the gantries were back in Solon and production was proceeding to inspect and disassemble equipment in order to evaluate and order items where necessary. Onsite, local 15 mechanics and local 147 sandhogs worked diligently identifying, disassembling and evaluating system components. Major failed components, such as grout pumps, drive motors and propulsion hydraulic blocks were shipped by truck back to Solon for repair, while less complicated items were ordered for shipment directly to site. Additionally, a local hydraulic supply house was selected to provide onsite hose making capabilities up through 2 inches diameter. In this way, replacement of worn hoses could be produced as needed saving precious time.

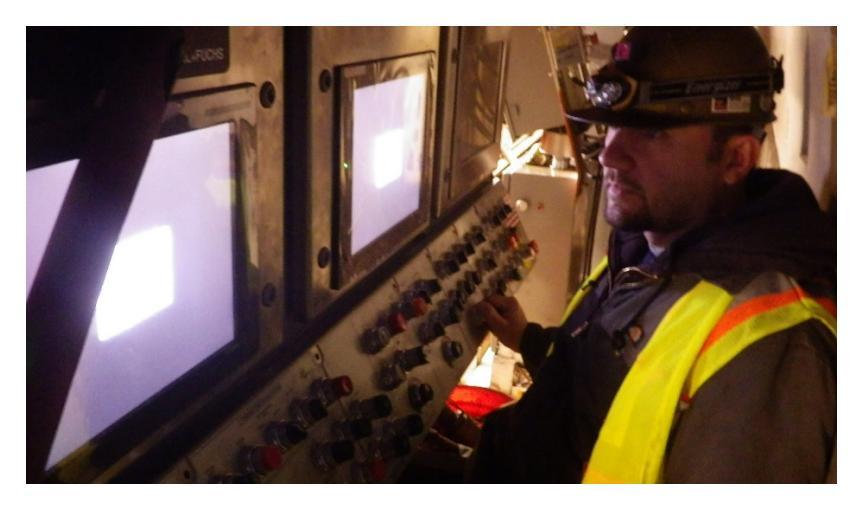
Figure 10. Technicians bring the TBM back online after reverse engineering electrical and computer systems.

Work continued at a feverish pace through the holiday season as Tully/OHL USA prepared to return to mining. By January 2014, the majority of physical systems were in place in the tunnel and the Robbins PLC technicians began the monumental task of bringing the newly reassembled machine back to life electrically. The Mitsubishi PLC was initially set up by Robbins Electrical Engineers. Several Robbins field service electrical technicians were brought to site to help guide electrical connections, and supervise installation of the many network communication lines (see Figure 10).
