The return of TBMs to Norway at Røssåga HEPP – TBM operation through extremely hard rock, unstable rock mass and other challenges

S. Log The Robbins Company, Oslo, Norway

D. Brox Leonhard Nilsen og Sønner, Bodø, Norway

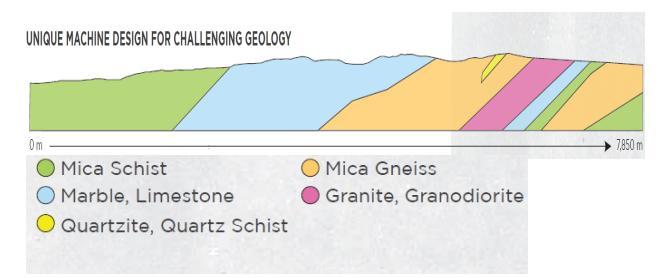
Figure 1 Baseline geological profile (Robbins 2013)

The tunneling works consist of 7400m long main headrace tunnels. In addition, it was decided to bore the access tunnel at a decline of 10% and a curve radius of 500m. As well, the project including building a new underground power station and other tunneling works related to the new power station. The geological report for the project showed rock types that were favorable for mechanized excavation, including Schists, Mica Gneiss, marble, limestone and one zone consisting of granites (see Figure 1).

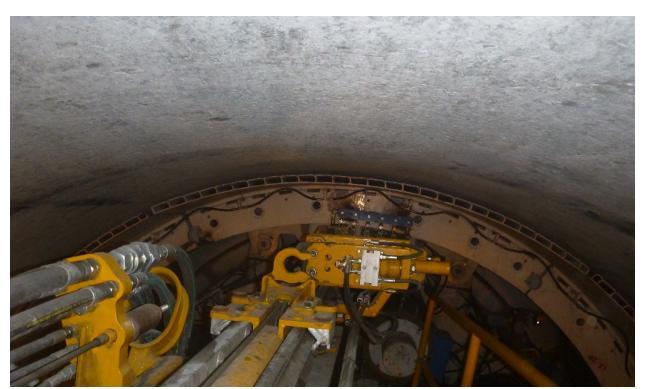
Figure 2.McNally slats in the shield and probe drill (Log)

The TBM was equipped with two rock drills on 180-degree movable rings for rock bolting as close to the forward shield as possible, as well as one probe drill on a 360-degree ring. In addition, the McNally roof support system was integrated into the forward shield for efficient installation of rock support. The main rock support methodology consisted of rock bolts and McNally slats for primary support (see Figure 2). A shotcrete robot was installed at the bridge and there was an option to apply manual shotcrete in the L1 area if heavier support was needed.

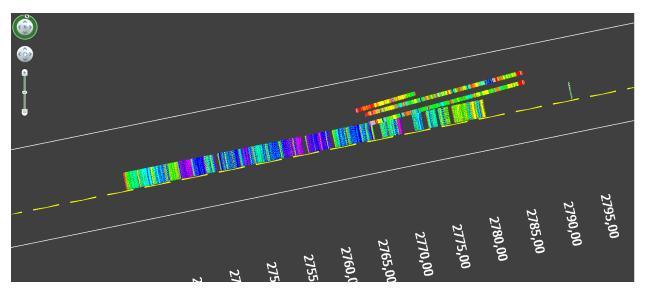
Figure 3. Screen print from the MWD system provided by Bever Control (Bever)

To prepare the TBM for detection of the karstic conditions, Robbins and the Norwegian company Bever Control developed a specially designed Measurement While Drilling (MWD) program for the TBM. This was installed on a Montabert HC 110 probe drill with feeder supplied by Andersen Mekaniske Verksted (AMV). The TBM also had the capability to install an additional probe drill if needed. The Measurement While Drilling (MWD) system provided electronic visualization of probe drill data in the operator cabin.

The MWD data was automatically analyzed in the office and interpreted with the TBM performance into a geological model as given below in Figure 3.

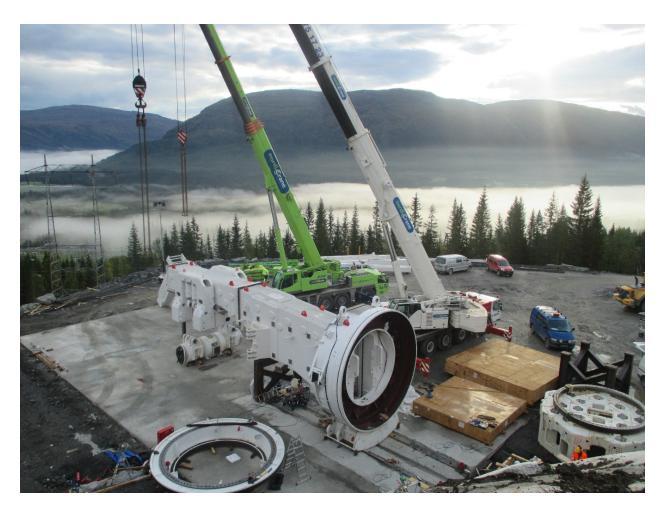
Figure 4. OFTA assembly at Røssåga (Gibson 2013)

A good team consisting of Robbins experts and LNS labor made an efficient assembly despite weather and snow challenges during the assembly (see Figures 4 and 5). The TBM and backup gantries was assembled and ready to bore by mid-December 2013.

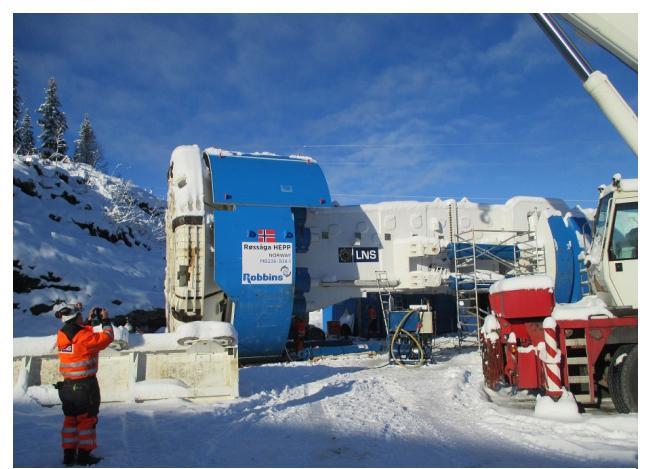
Figure 5. Assembled TBM in the snow (Solhaug 2013)

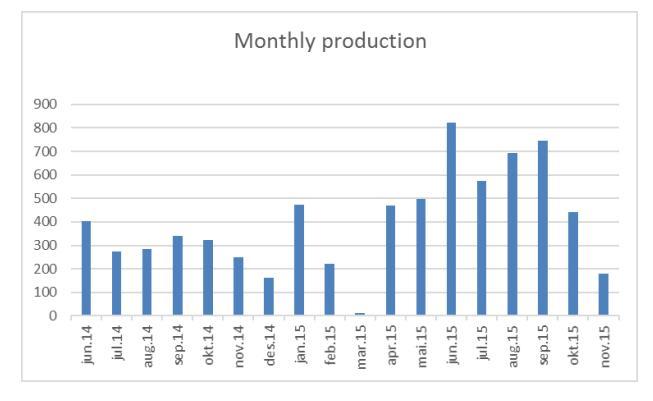
Figure 6. Monthly production at Røssåga (Log)

After the initial start the production stabilized in the very hard rock with some months of reduced production due to unforeseen incidents (see Figure 6). These included a damaged gripper shoe and repair in December 2014, main bearing replacement in March/April 2015, and heavy water inflow in November 2015. All these three happenings will be described later in the paper. It is also worth mentioning that July, December and March/April have less operation hours because of the Norwegian holiday periods.

After the initial very hard rock, boreability improved in October 2014 and this, together with a more skilled crew, contributed to more efficient operation. After this period the production stabilized at 500m and above in production months, with monthly highs of above 800m.

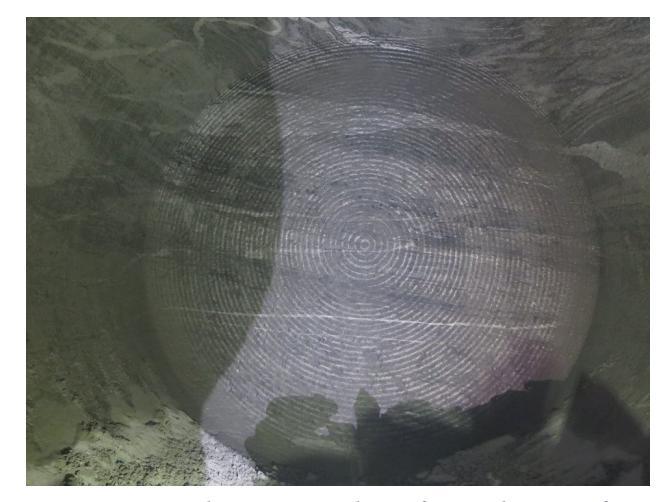
Figure 7. Extremely massive and non-fractured cutting face (Anderson)

Immediately after the TBM started boring, extremely hard rock with average rock strengths of above 200 MPa and some zones with strengths above 280 MPa were encountered (see Figure 7). In addition, the rock was massive with very limited fracturing, with NTNU fracturing classes below St. I- and highly abrasive with Cutter Life Index (CLI) values ranging from 4,5-11 and averaging just above CLI=5.

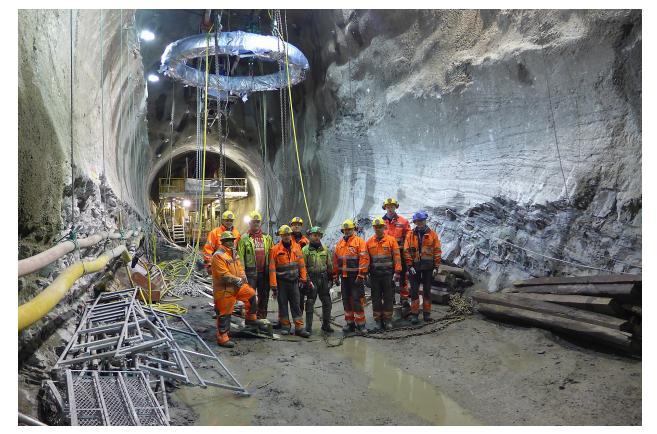
Figure 8. Workers during Main Bearing replacement (Anderson)

The procedure of a main bearing replacement for a Main Beam TBM in the tunnel is as follows: 1) Blast a niche with 25m length and 3.5m height in the crown behind the TBM and install lifting equipment. 2) Unbolt the current cutterhead and bolt it to the tunnel face. 3) Bring in new main bearing and hang it up in the niche. 4) Walk TBM back to the niche. 5) Change main bearing and hang the old main bearing in the niche. 6) Walk TBM up to the tunnel face and bolt on cutterhead. 7) Remove all main bearing components and reconnect TBM. 8) Ready to bore.

The main bearing was transported by truck from Germany and was already ready at site on the 2 March, less than two weeks after the decision to replace the main bearing was made. This was two days before the niche was finalized and the lifting equipment installed (see Figure 8).

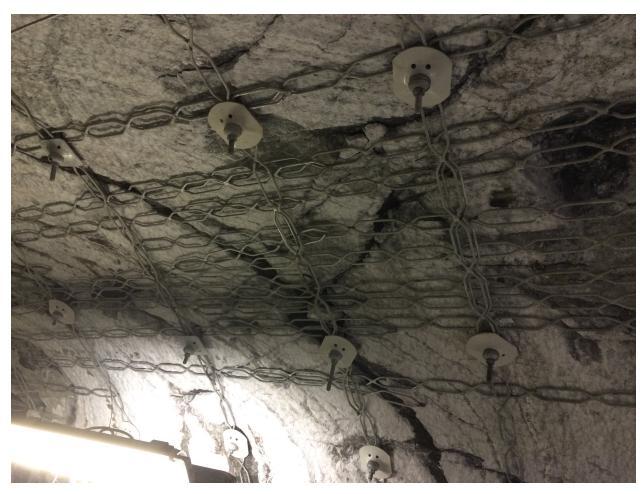
Figure 9. Example of efficient use of the McNally system (Log)

Even though the rock is described as massive with limited fracturing previously in the paper, there was still zones of the tunnel that needed rock support. The rock support methodology on the project was proven to be highly efficient. The McNally system was utilized with rock bands and bolting, which allowed for continuous advance of the TBM under supported rock (see Figure 9).
