A Smart Disc Cutter Monitoring System Using Cutter Instrumentation Technology

Kamyar Mosavat • The Robbins Company

ABSTRACT

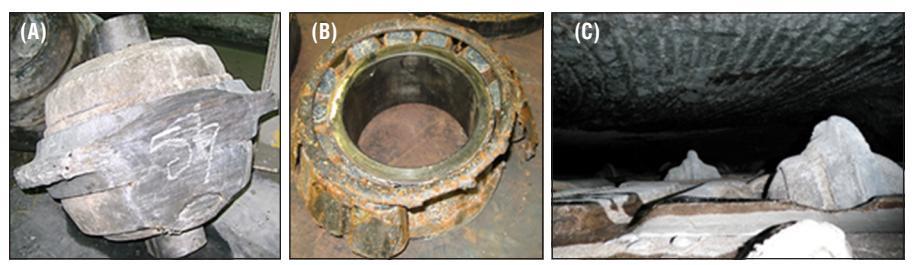
Figure 1. (A) Wiped out cutter wear; (B) damaged bearing; (C) face of excavation

In mechanized tunneling continuous information from the excavation face is essential. The ultimate goals of cutter instrumentation are to monitor real-time individual cutter operation, acquire more realistic cutterhead thrust force values, and gain a better knowledge of the geology in front of the cutterhead. Analysis of this information can provide in-depth knowledge of machine excavation. Information about cutter operation has direct and indirect advantages: It helps better predict and monitor cutter usage rates, and it can reduce the cost of unplanned cutter or ring replacement, which can result in a better planning of inventory, manpower, and cutter rebuild requirements. Another merit of cutter instrumentation is to maintain assembly health by monitoring individual cutter operation. An instrumentation system can notify an operator of uneven or harsh ring wear and makes it possible to prevent unnecessary seal or bearing changes. Additionally, it can prevent cutterhead damage caused by a late cutter change (see Figure 1).

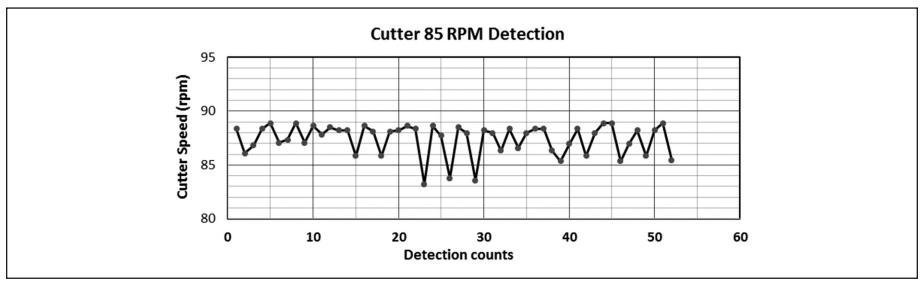
Figure 2. Niagara Machine first attempt (2008)

During an experiment in 2007, successful radio communication was established with a radio transducer and a receiver. Further in 2008, in an attempt to read cutter rotation, one instrument was built and installed in the Niagara TBM-a 14.4 m diameter open type, hard rock machine and the largest in the world of its type. The instrument was installed in the cutter housing and mounted to the wedge bolt. The system survived for a short period of time and provided spotty cutter speed data (See Figure 2). In 2009, an attempt at resolving the data readings problem led to the design of a new instrument prototype. In the same year five of those instruments were welded to cutter housings of a 12.4 m diameter open type hard rock machine for China's Jinping-II Hydropower project. This effort improved the system and outlined the outstanding issues. The welded mounting was not convenient for field staff, instrumentation enclosure worn out quickly, and the readings were spotty. As a result, the wedge bolt mounting option was selected as the most reliable design that maintained a good life for the enclosure. Furthermore a stainless steel sleeve was used to cover the plastic enclosure to prevent abrasive material from damaging the instrument. Between 2010 and 2012 the Niagara TBM, as well as three more open-type TBMs for Malaysia's Pahang-Selangor Water Tunnel, were equipped with the new prototype. Cutterhead speed was entered manually to calculate the cutter wear on the Niagara TBM (See Figure 3a) and later acquired from the PLC in Malaysia (See Figure 3b). Longer survivability of the instrument along with better radio communication was a turning point in the prototype design. The cutter instrumentation issues were alleviated to a certain extent and the enclosure survived longer than previous prototypes. However some issued remained.

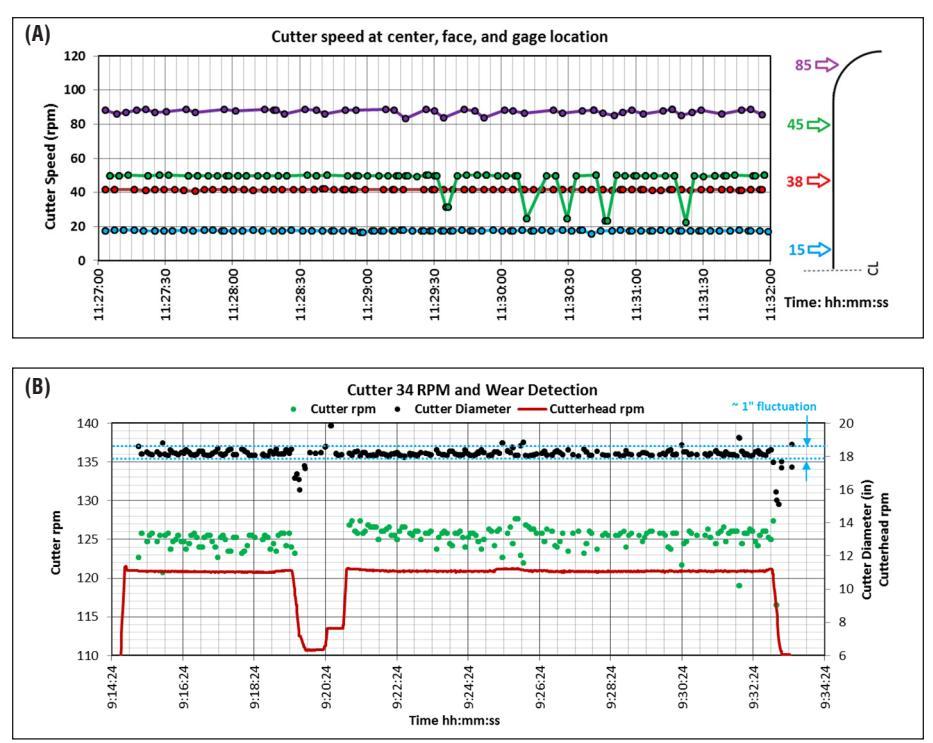
Figure 3. (A) Niagara second attempt (2010); (B) Malaysia Pahang-Selangor (2012)

Cutter speed measurements in Niagara were clearly correlated with the locations showing a decrease in speed from the gage toward the center. In Malaysia the cutter speed was fluctuating within 5 rpm and not enough data was available to analyze and smooth the data. Wear results were fluctuating within a 25mm (~1in) boundary. Although the wear measurements were not satisfactory, it was helpful to demonstrate that cutter speed was in the correct range. A computer screen was developed as an interface to control the operation (see Figure 4).

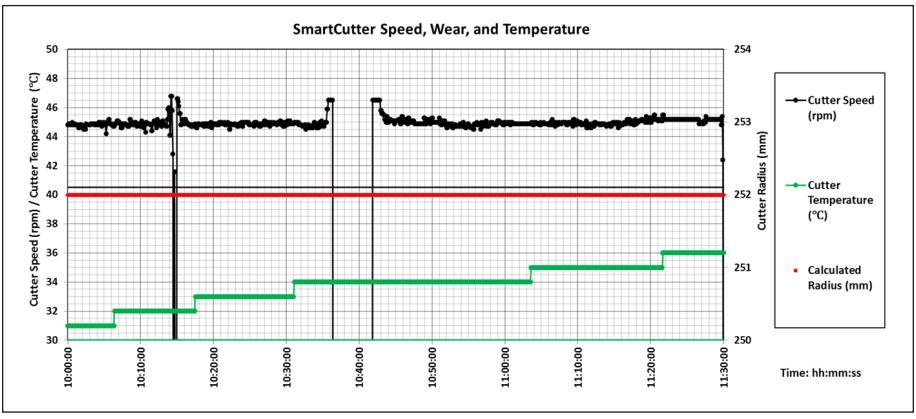
Figure 5. Malaysia Pahang-Selangor operator SmartCutter display

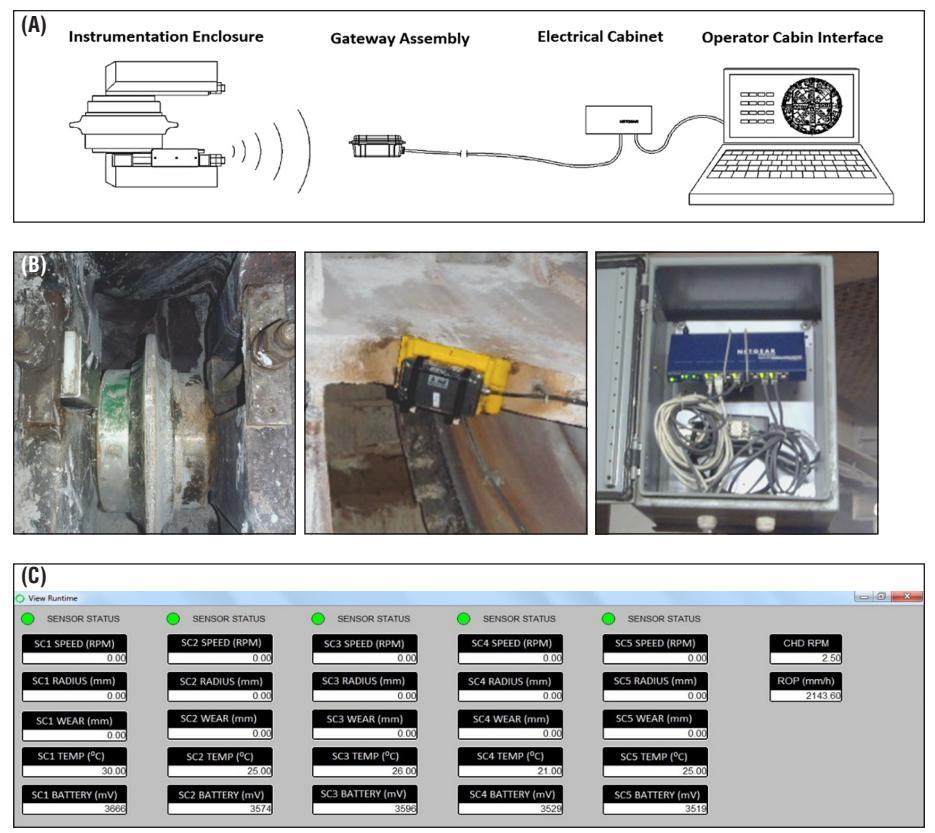
Figure 6. AMR project (2016) (A) system diagram; (B) equipment installation; (C) test monitoring platform

Figure 6a shows the AMR SmartCutter system diagram. Each instrumentation box was installed on the wedge bolt of the cutter housing. Two gateways were installed on the structure of the machine conveyor (See Figure 6b). Two gateways ensured the communication link was maintained at all times. In the event of a loss of communication the

operator was alerted on the monitor with a red alarm (See Figure 6c). The instrumentation battery capacity was increased beyond the normal cutter wear life, meaning that instrumentation could operate throughout one or more cutter changes. Additionally, the battery capacity and status was continuously reported and displayed on each instrument at the operator screen.

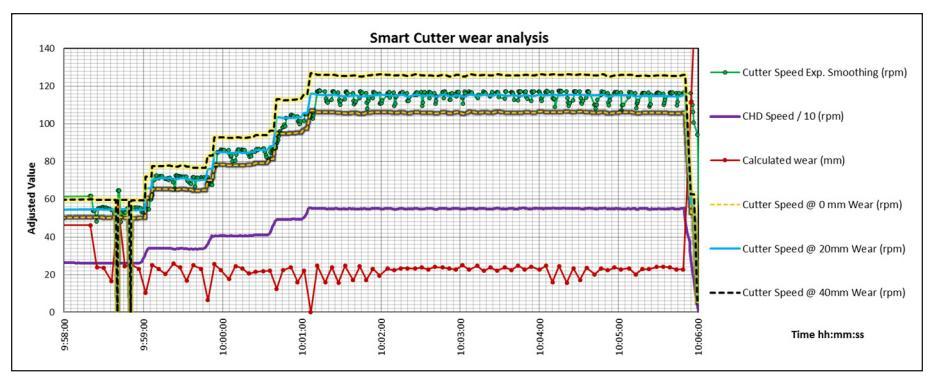
Figure 7. Eight minutes of unfiltered SmartCutter data from AMR (micro analysis)

Figure 7 shows eight minutes of unfiltered data for a single cutter. In this plot anticipated cutter speed at a certain amount of wear and instant ω_{CHD} are presented. ω_{DC} of both a brand new disc and a worn out disc are shown in orange and black dashed lines, respectively. The blue line represents the anticipated ω_{DC} at 20mm wear. The ω_{DC} reading is shown in green dots. This value is calculated from reported cutter

complete revolution time. In a normal cutter operation ω_{DC} is expected to remain between anticipated minimum and maximum anticipated cutter speed. From this figure one can determine that the highest speed that has the majority of the data represents the normal speed in which the cutter is rolling without interruption. If there are any hiccups where less than true rolling occurs, a reduction in ω_{DC} is to be expected. The cutter wear is calculated from ω_{DC} and is plotted in the red line. ω_{DC} perfectly correlates with the changes in ω_{CHD} at every step between 9:59 to 10:01 as it was expected.

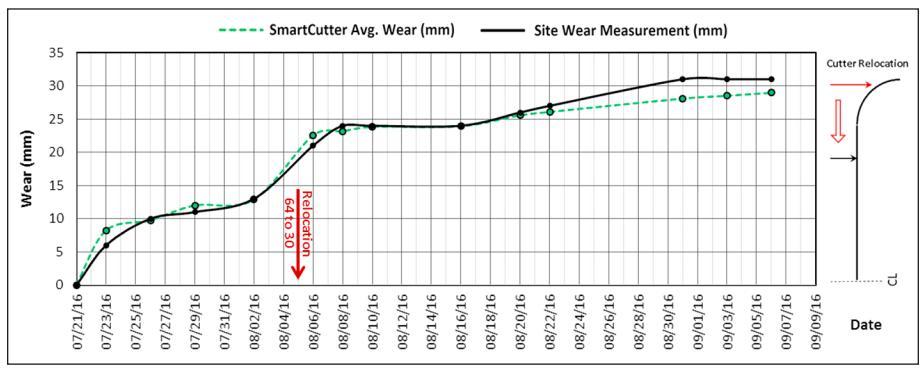
Figure 8. SmartCutter wear reading in comparison to job site measurements for SC1

Figures 8 and 9 shows the wear results of all five SmartCutters after increasing the ω_{CHD} by 1.03. The Cutter relocation is also displayed on these plots. This macro analysis shows a very close correlation of SmartCutter average wear values and the actual field measurements on the cutters, especially within the bold increases in wear (i.e. Figures 8 and 9c).

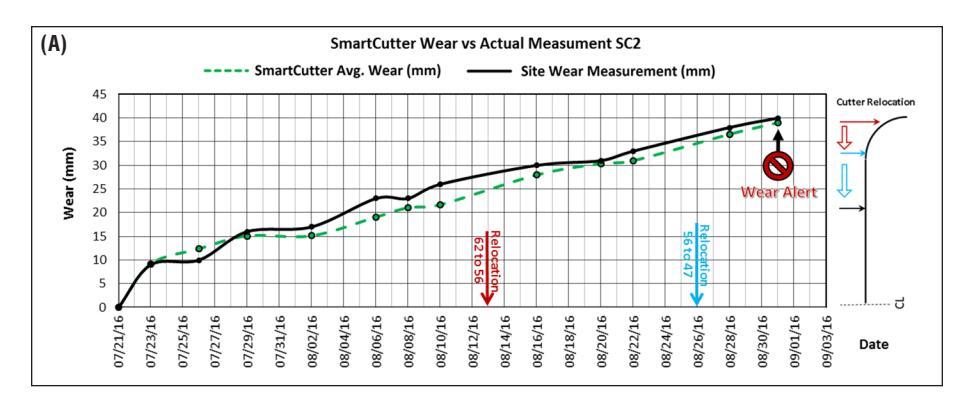
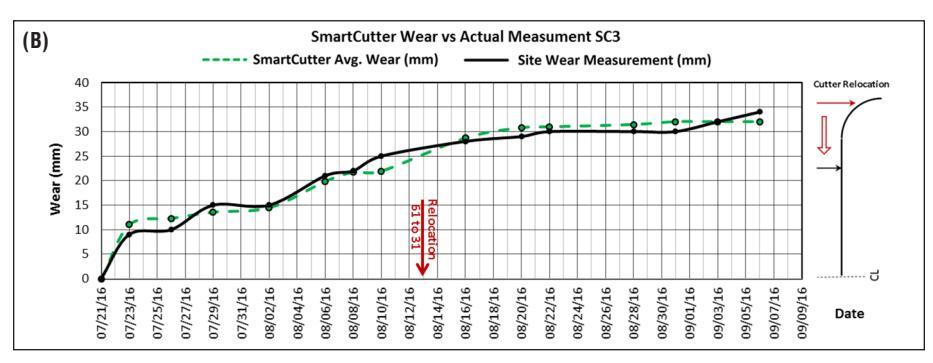
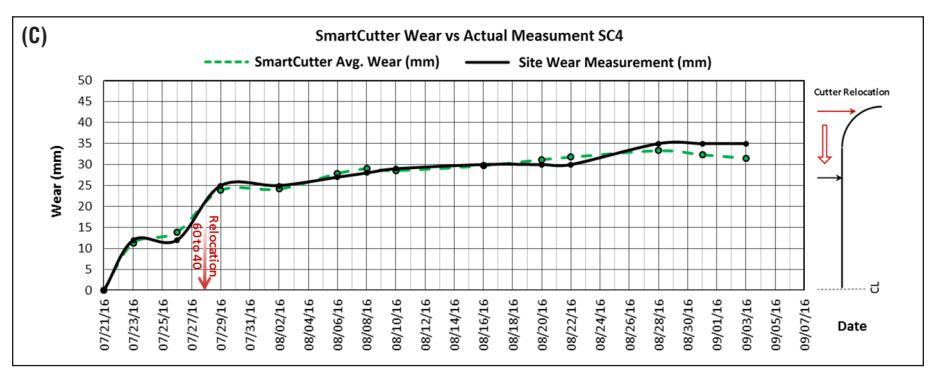
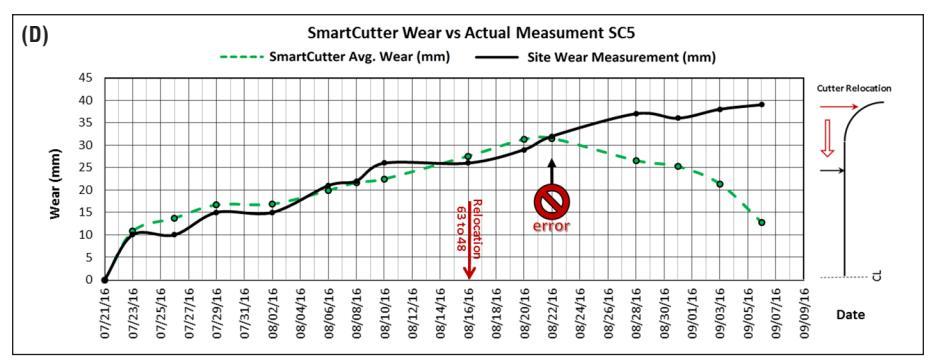
Figure 9. SmartCutter wear reading in comparison to job site measurements for SC2 to SC5

Figure 9d shows an error, which means although sensor status was correct the rotation was not measured quite satisfactorily. This is the result of interruption in cutter rolling (i.e. an uneven cutter ring wear), which caused longer revolution time and consequently lower wear values. In such conditions an error is displayed to alert the operator regarding ω_{DC} and the program will only post the maximum previous wear. The latest cutter disc radius is used to plot and display the anticipated ω_{DC} and the operator can review ω_{DC} timeline and locate when the problem starts (in this case 8/22/16). Figure 9a shows an alert that informs the operator that the cutter is close to the maximum wear. Operators can set certain wear limits for each cutter in the program alert setting. In many cases alerts can prevent unexpected cutter ring wear-related issues from causing further damage to bearings and hubs.

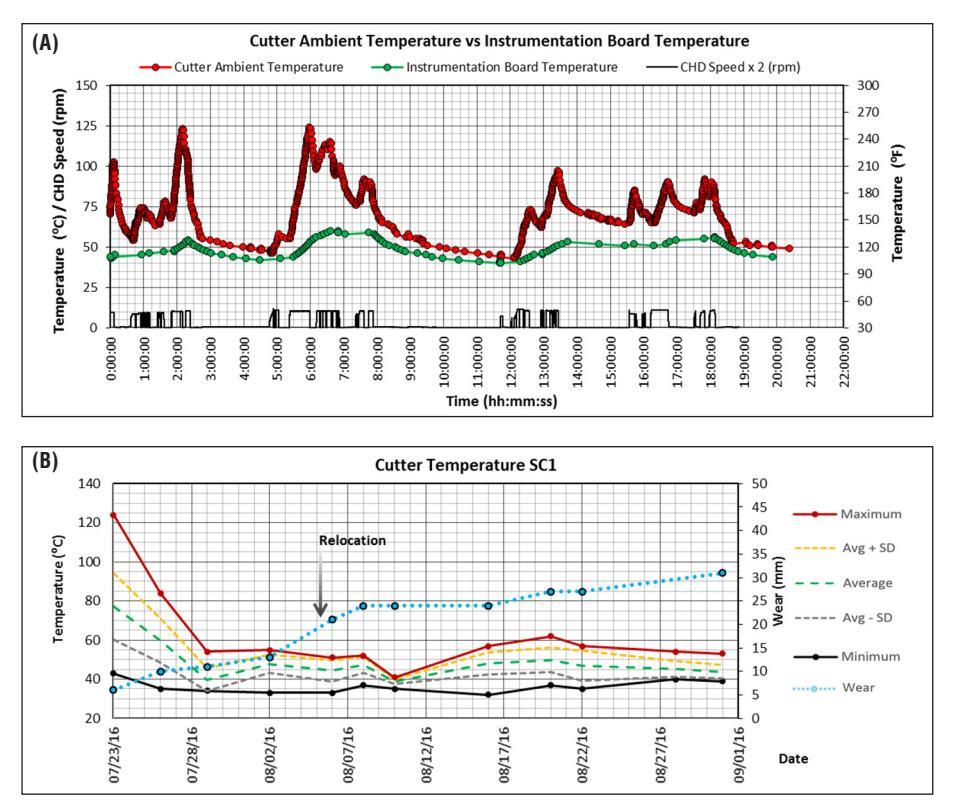
Figure 10. SC1 cutter temperature (A) during one day of mining; (B) during continuous days of mining

The cutter instrumentation system constantly monitors the cutter assembly's temperature and displays it on the operator's screen. The main purpose of recording this parameter is to scan the cutter assembly function and identify abnormal ring temperature. In highly abrasive geologies or high strength rock material, disc cutter ring temperature will ramp up. This can cause higher wear and, if it passes the lubrication boiling temperature, it can cause bearing damage. In extreme cases it can result in seal failure due to rapid increase in internal pressure. Board temperature is also shown to confirm that in the current design the electrical board and battery is kept at a low enough temperature to maintain reliable performance. Additionally, this information can be coupled with other cutter parameters and provide an insight into cutter operation. Figure 10a shows the temperature of a brand new cutter throughout several mining periods during one day. During cutterhead standstill natural ground temperature can be observed (i.e. time 3:00 to 5:00 and 9:00 to 12:00). This plot shows that the temperature of the brand new cutter was high in the beginning (125°C) and decreases gradually. One possible explanation is that the cutter experiences high stress at the brand new cutter rounded tip corner at the gage area and as it wears for a few millimeters, the stress reduces and temperature drops under 100°C. Figure 10b also confirms it by correlating wear and temperature in macro analysis within successive days of excavation. In this plot the blue dash line shows the wear. Temperature is shown with a maximum, minimum line, and average values in green dashed line.

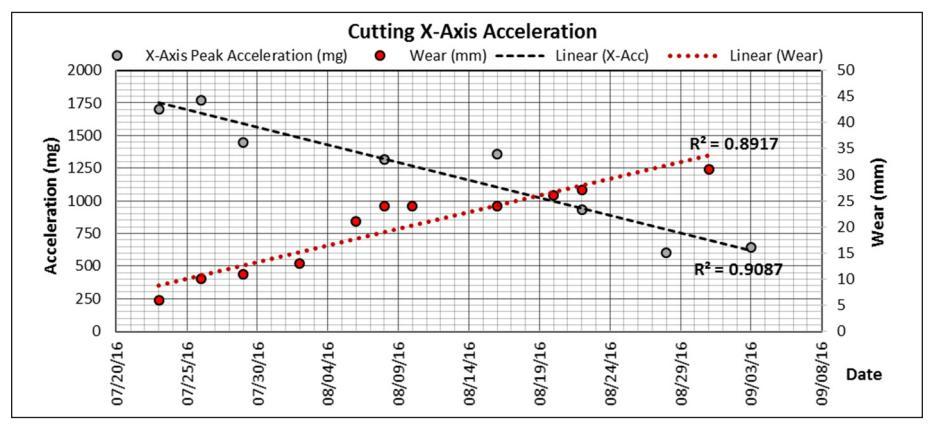
Figure 11. SC1 peak vibration in comparison with cutter wear within continuous days of operation

The wireless radio technology that is used in the SmartCutter configuration provides some limited bandwidth for data transmission. The accelerometer used in the SmartCutter reports acceleration in the X, Y, and Z direction as well as the peak acceleration. The time domain analysis of these data can provide some insight into cutting action and the geology in front of the machine. However, for distinguishing ground characteristics, frequency domain analysis will be essential, which requires an enormous amount of data to be transmitted and processed. Excavation propagates a certain range of vibration that is influenced by cutting action, cutter assembly mechanism, disc cutter ring condition, geology, and other machine noises. The hidden dimension is the power and frequency of all individual parameters. For instance, one can claim that geology-related vibration frequencies vary with material type or changing conditions within identical geologies. Figure 11 shows a time domain macro analysis on average of peak acceleration perpendicular to cutting surface within a homogeneous geology. It is very clear from this plot that as the cutter wears out the acceleration drops down gradually. Although frequency domain analysis is believed to reveal useful information on geology and cutting pattern, it is not included in the current SmartCutter package.
