TBM Tool Wear Analysis for Cutterhead Configuration and Resource Planning in Glacial Geology

Ulf Gwildis and Jose Aguilar CDM Smith

Kamyar Mosavat The Robbins Company

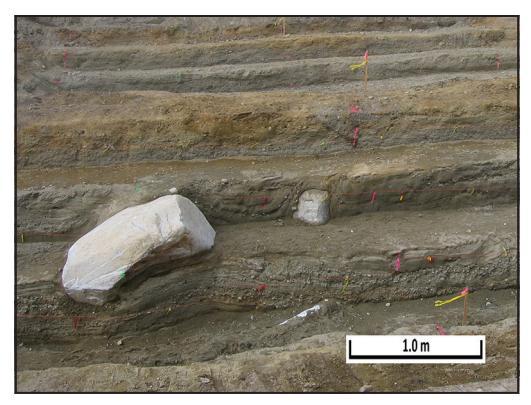
Figure 1. Excavation exposing glacial deposits in the Seattle area

The term glacial geology encompasses a large variety of deposits ranging from fine-grained lacustrine and marine deposits to coarse grained meltwater (outwash) deposits to ice-contact and till deposits with a wide range of grain sizes including cobbles and boulders (Figures 1 and 2). The boundaries of these deposits are typically highly variable and discontinuous. Deposits overridden by glaciers are often very dense or hard. Generally glacial geology is known to be highly abrasive. Several geotechnical laboratory tests exist with the objective of quantifying soil abrasiveness (quartz content by x-ray diffraction, Miller number test for slurry abrasiveness, NTNU/SINTEF Soil Abrasion Test (SATTM), and others.); however, all these tests cover only a limited number of the soil characteristics that are considered causal factors of TBM tool wear. While these tests are valuable for providing contractual baseline descriptions of the subsoil conditions, the test results do not provide a sufficient basis for reliable tool wear prediction.

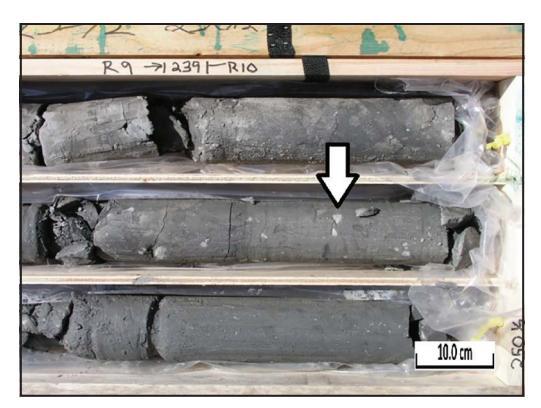
Figure 2. Core of glacially overconsolidated clay matrix with sharp-edged coarser components

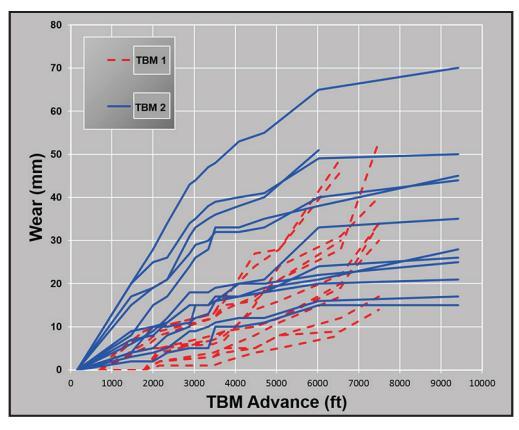
Figure 3. Accumulative tool wear over TBM advance length

Plotting the accumulative wear of the various tool positions over the advance length of the TBM—the spread of the graphs reflecting the differences in travel path length as function of the tool position radius on the cutterhead—already shows changes in the graphs' gradients (Figure 3). The selected examples show that the changes in gradient are

synchronous and that the tool wear rates of linear sections, when normalizing them for tool travel path length, are quite similar. This indicates that the tool wear is a steady and continuous process although at changing rates over the TBM advance length leading through various soil types. In this scenario, the wear can be interpreted as being caused by variable soil abrasiveness characteristics, by changing TBM operational parameters, or by a combination of both. For normalizing the tool wear W (mm) for travel path length L (mm) a normalized wear parameter NWP is used, which is dimensionless and defined as NWP = $(10^8 \times W)/L$. Putting it in context with the specific energy consumption of the TBM (i.e., the product of cutterhead torque and rotation in relation to the excavated soil volume) as well as the average soil abrasiveness of the soil types excavated between two tool wear measurement locations provides a loose correlation (Figure 4). This correlation seems to confirm the applicability of soil abrasiveness descriptors such as SATTM values for quantifying tool wear (Gwildis et al., 2010). In this specific project example slurry TBMs with high-opening ratio cutterheads and disc cutters as primary cutting tools were utilized. During the two drives boulders were encountered. Observation of rock fragments in the spoils seemed to indicate that the disc cutters excavated the boulders by rock-chipping mechanism as long as they were held in place by the very dense or hard soil matrix of the glacially overconsolidated deposits. In one case the rock chipping reportedly continued till the time when the direction of cutterhead rotation was changed by the TBM operator and the boulder became dislodged, at which point an intervention for manual removal of the remaining boulder became necessary.

The observed phenomenon is interesting especially when compared to the symmetrical tool wear recorded for the slurry TBM operation described earlier (Figures 3 and 4), where flat-spotting and tool damage recordings were rare events despite significant sections of that drive involving fine-grained glacial soils. Further research may be directed at the interaction of EPB TBM operation, soil conditioning, and tool performance. Collecting tool performance data by continuous data logging would likely yield a valuable data basis for this research.

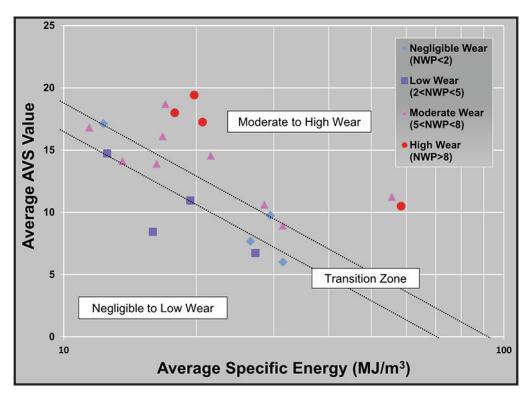
Figure 4. Normalized wear data (disc cutters) plotted over specific cutterhead energy consumption and soil abrasiveness descriptor (SATTM)

The results of Figures 3 and 4 could not be replicated at a TBM drive through glacially overconsolidated interglacial and then glacial deposits, where

If the distribution of tool wear over the face of the cutterhead is symmetrical, there is an increased probability that some correlations between soil abrasiveness descriptors, TBM operational parameters, and tool wear measurements normalized for tool travel path length can be found (Figure 4). Examples for symmetrical tool wear are provided by Figure 3, where a slurry TBM equipped with disc cutters excavated a variety of glacial soil types including boulder conditions without experiencing significant tool damage, and by Figure 17, where an EPB TBM equipped with ripper-type tools had excavated a tunnel section through face conditions dominated by glaciofluvial sands and gravels.

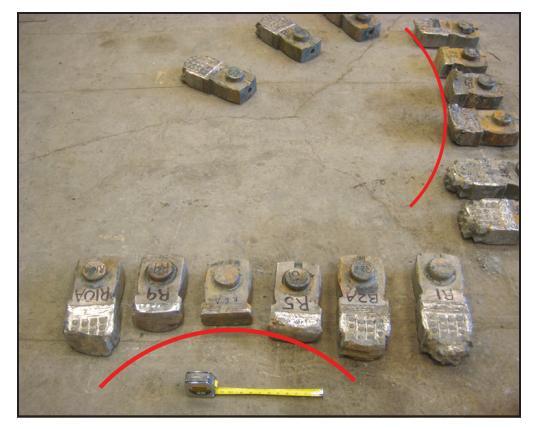
Figure 5. Layout of replaced TBM tools per cutterhead positions

an EPB TBM with a cutterhead equipped with ripper type tools as primary cutting tools was utilized. Applying the same methodology as before does not show harmonious and continuous tool wear, which would have resulted in a symmetrical wear pattern over the face of the cutterhead (under consideration of tool changes) (Figure 5). Nor are there any correlative trends observable in the diagram of normalized wear over average specific cutterhead energy consumption and average soil abrasiveness descriptors (Figure 6) (Shinouda et al., 2011).

Where EPB TBMs have been advanced through glacial soils that include till and till contacts, the latter often representing a depositional environment with an increased probability of the accumulation of boulders and cobbles, non-symmetrical tool wear distributions have been observed. Explaining irregular tool wear patterns of ripper-type tools with impact damage by boulders and subsequent accelerated soil abrasion seems likely in many cases (Figures 5, 7, 8, 12).

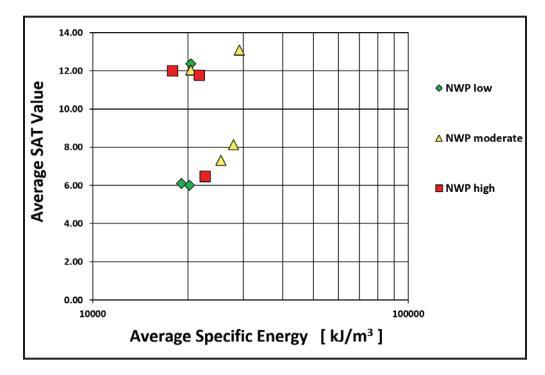
Figure 6. Normalized wear data (ripper-type tools) plotted over specific cutterhead energy consumption and soil abrasiveness descriptor (SATTM)

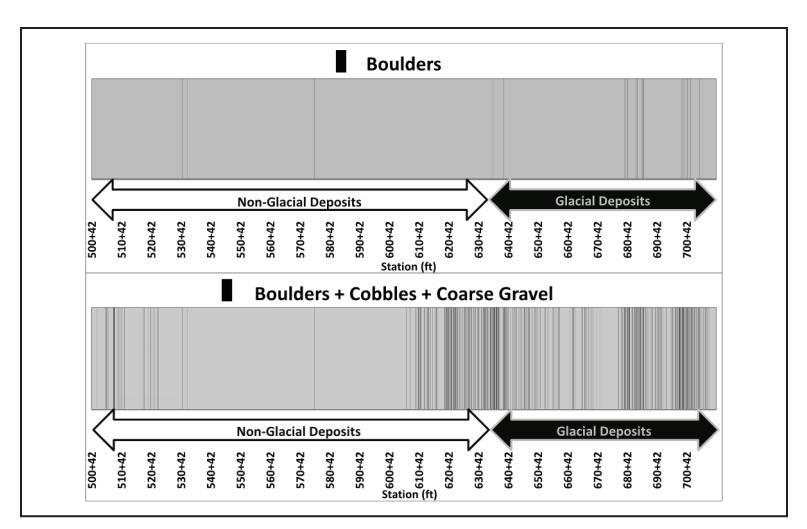
Figure 7. Coarse component tracking

a correlation while the comparison with specific energy consumption does not (Figures 7 and 8). This finding in conjunction with the non-symmetrical tool wear pattern over the area of the cutterhead points to impact damage sustained by the ripper-type tools when encountering coarse components (boulders, cobbles) as the dominating factor in this specific wear system behavior.

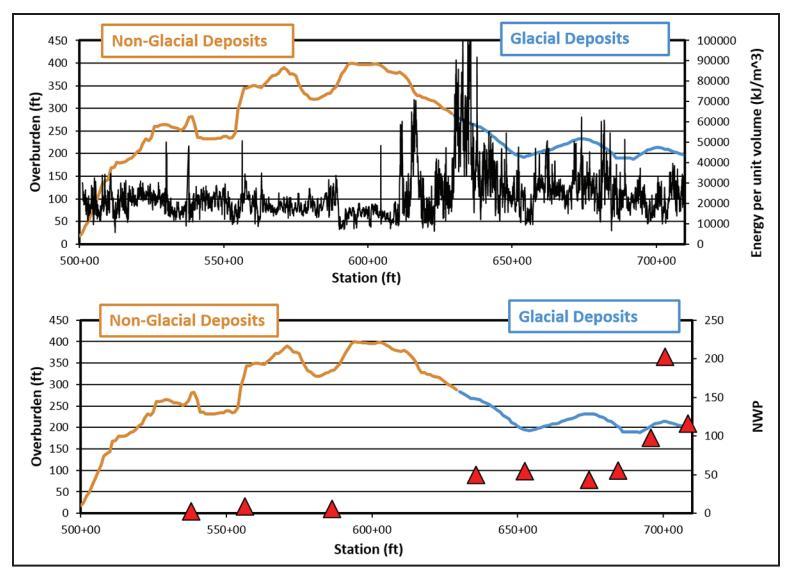
Figure 8. Specific energy consumption vs. tool change intervals and normalized tool wear

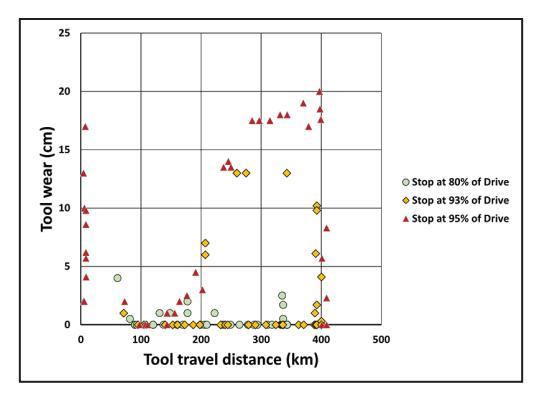
Figure 9. Tool wear measurements over tool travel distances

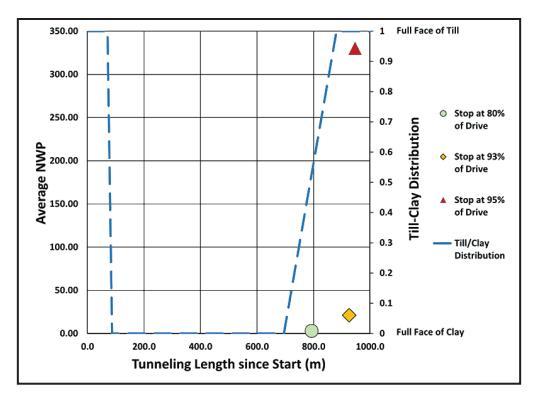
Figure 10. Relationship of average NWP values and geotechnical conditions

Case study project 1 includes an EPB TBM with ripper-type tools as primary cutting tools supplemented by disc cutters in gauge positions as well as scrapers. The tunnel alignment was excavated in clay and till. Significant differences in the tool wear rate were recorded during tool inspections at 80%, 93%, and 95% of the drive length. Plotting the wear measurements over the tool travel distance indicates low wear rates at the first inspection stop and significantly increased wear rates thereafter (Figure 9). Plotting the wear normalized for the tool travel distance as an average NWP value over the drive length provides a clearer picture of this wear behavior (Figure 10). Visualizing the advance lengths through the two soil units by the graph of a till-clay distribution factor with "1" indicting a full face of till and "0" indicating a full face of clay provides the geotechnical context and identifies the drive sections through the geologic contact. The relationship between tool wear rates and geologic contact sections does not point to the contact as the main contributor to the significant wear rate increase. This happens mostly in the full face of till near the end of the drive. Reported loss of soil conditioning functionality in this section would indicate lack of the associated mitigating effects (Hedayatzadeh et al., 2017) and therefore should be considered a potential factor.

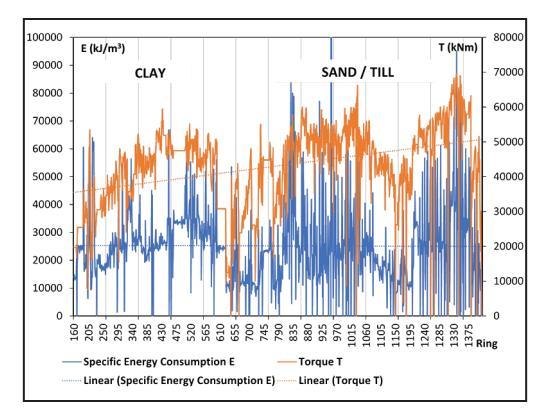
Figure 11. Cutterhead torque and specific energy over TBM drive length

(Figure 11). The graphs show a fluctuating but overall constant specific energy consumption while the torque, fluctuating in sync, shows an upwards sloping trendline. The tool wear measurements normalized for tool travel length indicate generally low tool wear rates in clay and significantly increased tool wear rates in sand/till (Figure 12). The latter show a wide margin of variation, pointing in addition to continuous wear by soil abrasiveness to other wear mechanisms as causal factors. The presence of till contacts in the sections between inspection stops where the highest normalized wear values were determined points to boulder impact damage as a likely explanation. This explanation is also consistent with the observation that the highest normalized wear values were determined at distal tool positions (positions at large cutterhead radii away from the center) on the planar face area of the cutterhead, where the travel speed and impact forces are high in comparison with other tool positions.

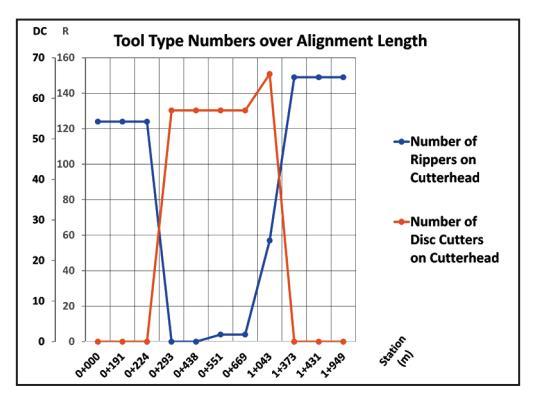
Figure 13. Dressing of the cutterhead with different tool types over the drive length

Case study project 3 includes an EPB TBM whose cutterhead was dressed using varying tool configurations of disc cutters and ripper type tools as primary cutting tools in addition to scrapers. The tool types at individual tool positions were changed as the TBM advanced through mixed face conditions consisting of interfingering layers of till and sands and later a full face of sand. At the start of the drive exclusively ripper-type tools were used; however, the tool type was soon changed to disc cutters while the TBM advanced in face conditions with frequent till contacts and the resulting increased probability of boulder encounters. The tool type was changed back to ripper-type tools when the TBM was advancing predominantly through a full face of sands (interlayered with silts and gravels) (Figure 13). Plotting the average of all tool wear measurements and observations for each inspection stop over the drive lengthin cases of asymmetric tool wear the maximum extent of material loss on a tool is considered-shows

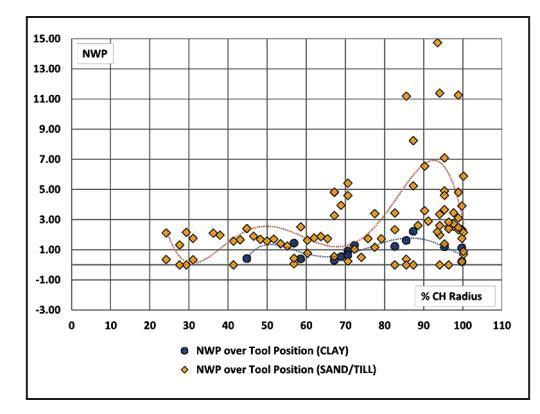
Figure 12. Normalized tool wear (NWP) over cutterhead radius

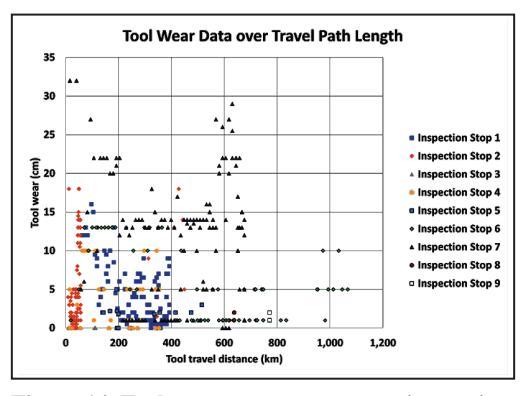
Figure 14. Tool wear measurements at inspection stops

generally higher wear in the mixed face sections of sands and tills as compared to the full-face sections in glacial sands. (Figure 14).

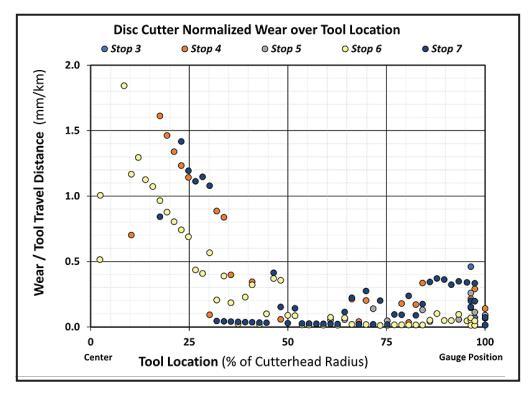
Figure 15. Normalized tool wear distribution of disc cutters by tool position

Taking a closer look at the disc cutters reveals in most cases of high wear measurement values that the wear is non-symmetrical due to flat-spotting of the cutter ring or tool damage significant enough that possible flat-spotting in the early stages of damage is not observable anymore. Plotting the disc cutter wear data over the cutterhead radius tool positions, a trend of higher wear at the inner tool positions, a trend that becomes even more pronounced if the wear data are normalized for tool travel path length (Figure 15). Identifying those tool positions where tool damage or flat-spotting has occurred is mirroring the tool wear distribution pattern, as shown exemplarily for one of the inspection stops (Figure 16).

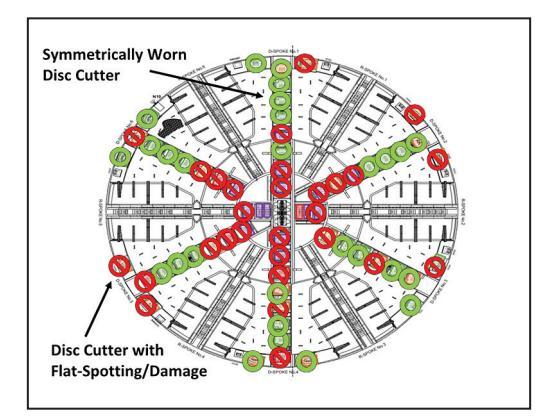
Figure 16. Example of distribution of disc cutter tool damage and flat-spotting on the cutterhead area

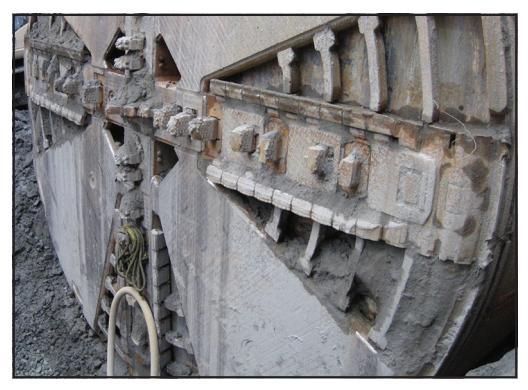
Figure 17. Cutterhead with symmetrical tool wear pattern (ripper-type tools)

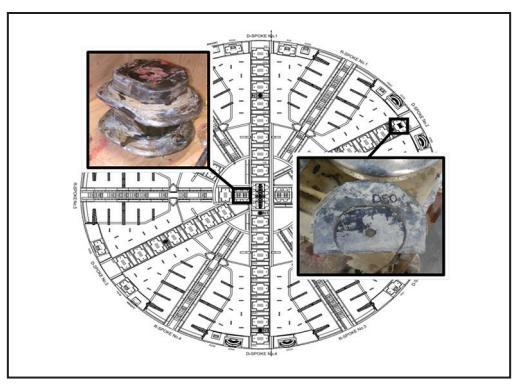
Figure 18. Cutterhead with non-symmetrical tool wear pattern (disc cutters)

Where ripper-type tools are used, boulders encountered in the tunnel face are broken into smaller pieces by impact forces. Arguably the applicability of this mechanism is limited by the size of the boulder encountered in the face. When disc cutters are used, the boulder may be excavated by rock chipping similar to the application of disc cutters in hard rock. This requires that the boulder is not dislodged from its soil matrix during the excavation process. In glacially overconsolidated soils, boulders are generally assumed to be embedded in a soil matrix of sufficient strength to offer resistance against being easily dislodged. However, when a non-symmetrical wear and damage distribution of disc cutters on the cutterhead is observed, this suggests a different excavation mechanism than rock chipping. Furthermore, a high number of damaged tools at radius positions close to the center of the cutterhead also points to factors beyond the risk of shock-loading and bearing failure due to boulder encounters (Figure 18).

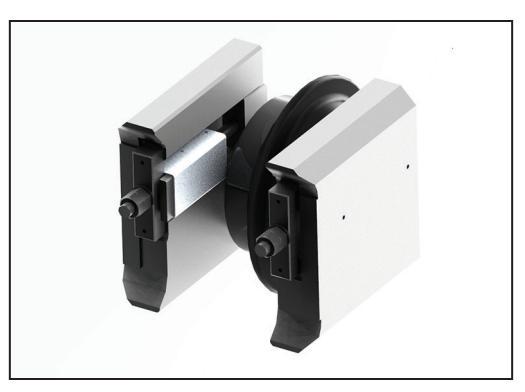
Figure 19. 3-D rendition of disc cutter housing with instrument box

The authors of this paper suggest considering continuous monitoring of disc cutter functionality by technology that has been used in hard rock applications (Mosavat 2017) (Figures 19 to 21). RPM

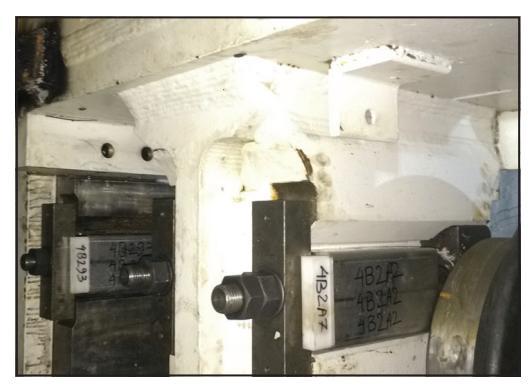
Figure 20. Disc cutter housing with instrument box (rotation speed and temperature)

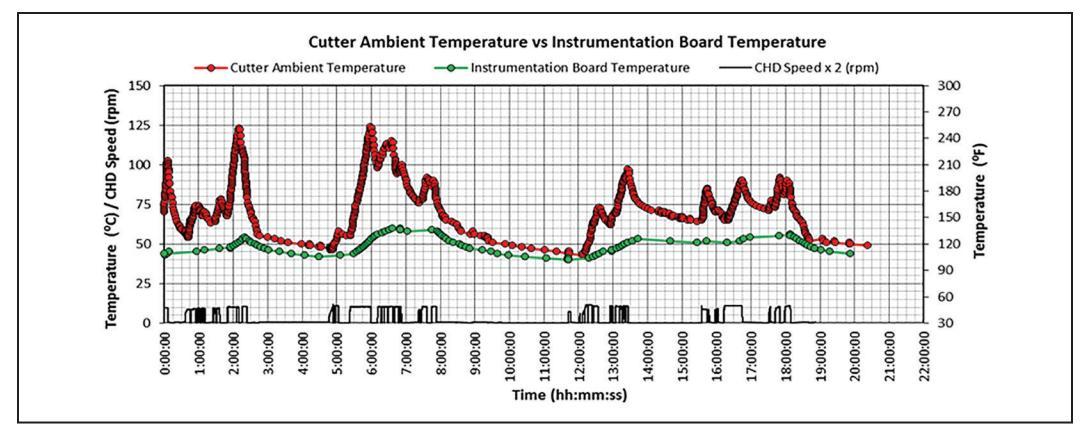
Figure 21. Example of disc cutter performance monitoring graph

recordings provide indications of flat-spotting while temperature readings may indicate the risk of tool blocking or particle cementation and baking, which inhibit effective excavation and material flow into the TBM excavation chamber. Response options could include changes in soil conditioning or adjustments of how the TBM is driven.
