Unprecedented In-Tunnel Diameter Conversion of the Largest Hard Rock TBM in the U.S.

Steve Chorley and Evan Brinkerhoff Robbins

IN SITU DIAMETER REDUCTION AT MILL CREEK

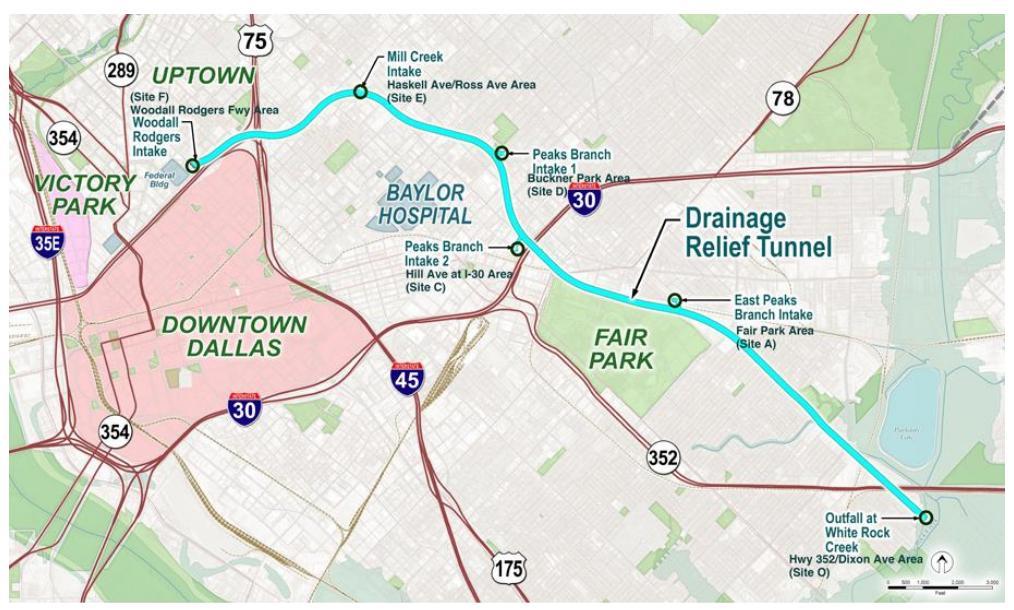
Figure 1. The 5-mile route of the Mill Creek Drainage Relief Tunnel. Source: www.millcreektunnel.com

The Mill Creek/Peaks Branch/State-Thomas (MCPBST) Drainage Relief Tunnel is a five-mile underground tunnel that will provide flood protection for the east Dallas area. The project required a drainage tunnel starting at a diameter of 11.6 m and ending with a diameter of 9.9 m. The upstream 5.2 km are designed with a circular cross section for a peak flow of 425m3/sec. The downstream 2.8 km, running between the outfall shaft to the East Peaks Branch Intake (see Figure 1), was originally designed with a horseshoe cross section to allow a higher peak flow of 566 m3/sec. The horseshoe section was to have been excavated by the TBM initially and expanded by roadheader to create a flat invert. Two different sets of formwork would also have been required to cast the final lining for both the round and horseshoe profiles, making the process potentially time consuming and costly (Rowland, 2019). Because of the cost and time to excavate by roadheader, one TBM was instead selected.

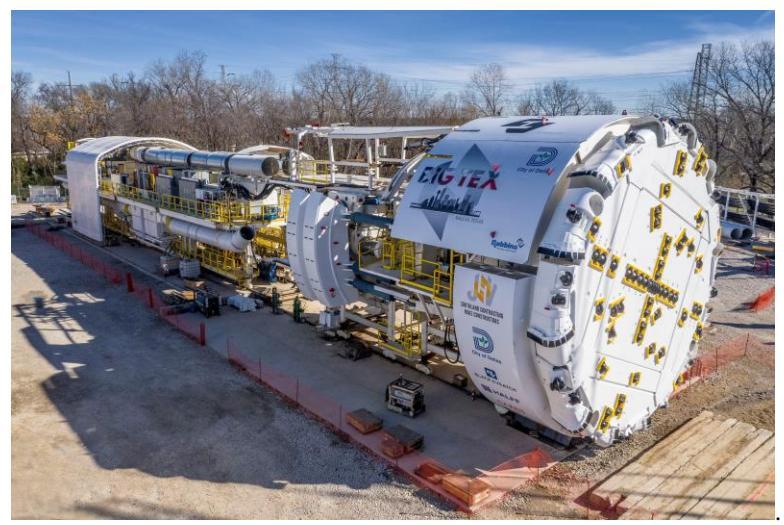
Figure 2. The 11.6 m diameter Robbins Main Beam TBM at launch, the largest hard rock TBM ever used in the U.S.

A Robbins re-built TBM along with a continuous conveyor (including a vertical conveyor) was chosen as the boring system. During early project discussions with the machine supplier, a decision was made to reduce the boring machine diameter in the tunnel, lowering project costs and reducing the construction period (see Figure 2).

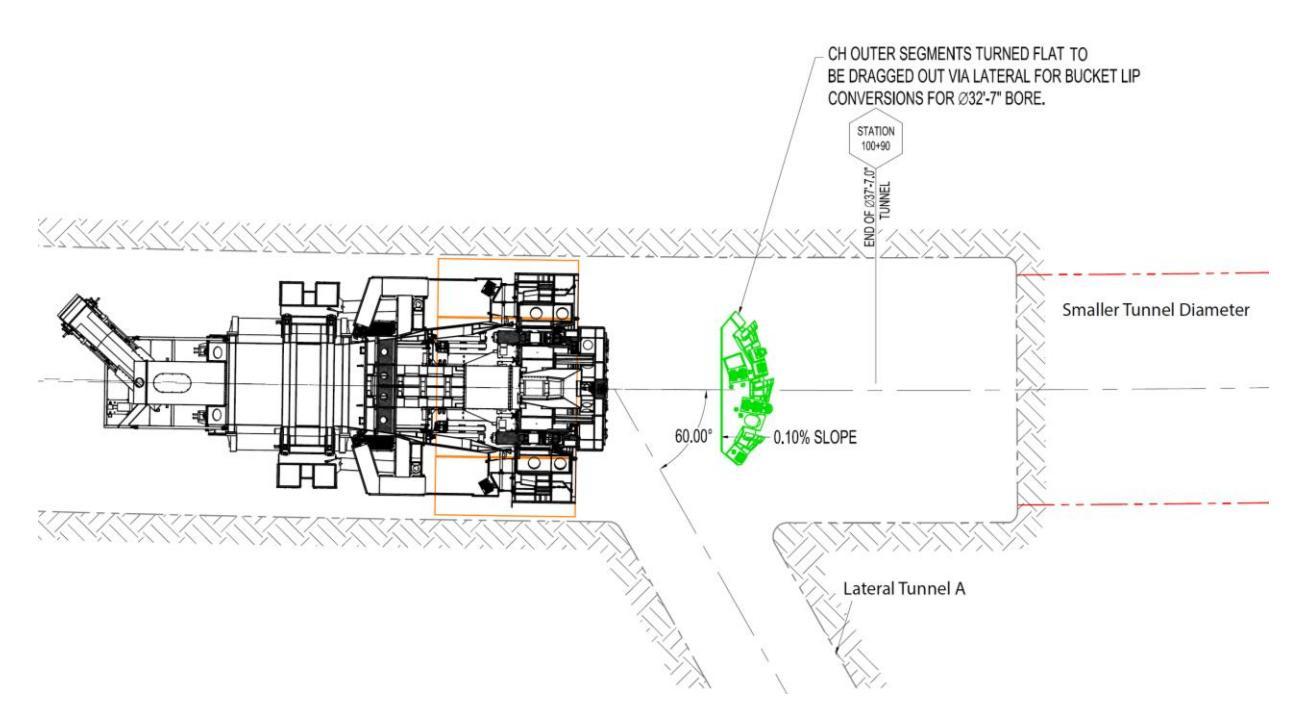
Figure 3. TBM Plan view in relation to Lateral Tunnel A at diameter change site.

personnel put their heads together and found a solution that required only backing the head a mere 76 cm. The process would be achieved by removing cutterhead sections and other pieces through Lateral Tunnel A, a 6 m diameter, 90 m long, horseshoe tunnel built using excavators and hydraulic hammers. The lateral tunnel connects with Drop Shaft A, at 52 m deep and 6 m in diameter. The arrangement allowed personnel and equipment to access and begin the conversion process through the lateral tunnel, and remove pieces on rails through the shaft and up to the surface (see figure 3).

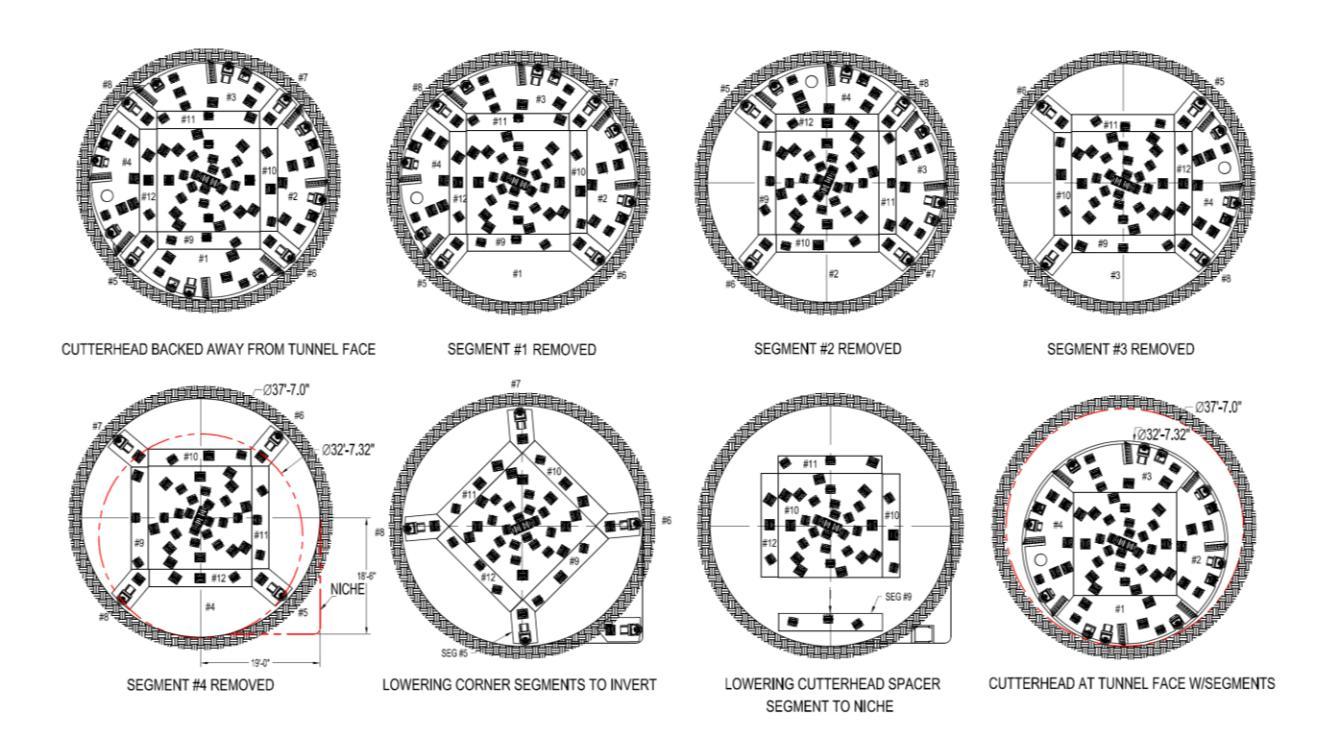
The reduction took place from the front of the machine starting with the cutterhead and ending with the conveyor. The cutterhead was designed to have four spacer segments installed between the cutterhead center section and the outer sections, with four small, intermediate sections filling in the gaps at the so-called corners (see figures 4 and 5).

Figure 4. Cutterhead diameter change sequence

The team dismantled and removed the four cutterhead sections, the four intermediate sections, and the four spacers from a lateral tunnel, lateral A, which intersected the main tunnel precisely at the diameter change. The heaviest section weighed just over 15,000 kg and given the small access window, required a bit of planning to maneuver the pieces out of the lateral access to the surface for re-fitting for the small diameter, and returning to the installation position.

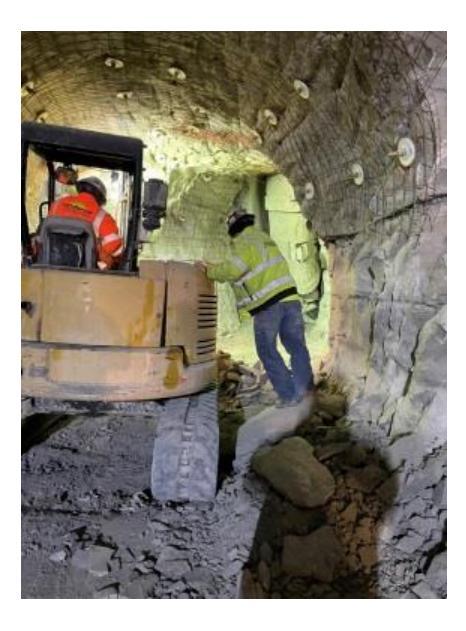
Figure 5. Cutterhead segments being removed in the lateral access

Working from the lateral tunnel, the welds securing the intermediate spacers were removed through the buckets. The team made the decision to remove the spacers in sections, cutting them from the lateral, leaving the mounting flanges in place. The spacers were then pulled from the cutterhead in sections.

The crews were then able to remove the cutterhead sections entirely from within the safety of the confines of the cutterhead and the lateral access. Working on the bottom section and from within the cutterhead, the crews then removed the fasteners and allowed the cutterhead section to rest on the invert. As the TBM was not retracted, the cutterhead sections settled in the invert nicely as they waited to be removed. To facilitate the cutterhead section removal, the cutterhead drive motors, controlled via variable frequency drives, were used to rotate the cutterhead and push the first cutterhead section out through the lateral where it could be collected and sent to the surface.

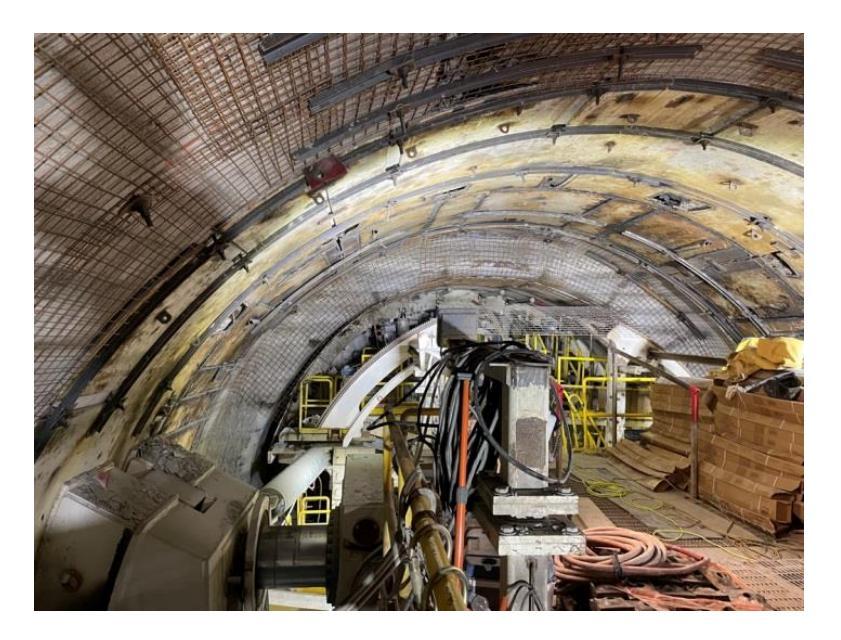
Figure 6. Transition area showing the roof shield skins and transition area from the top

Working from within the shield skin the crews removed the outermost skins from the roof supports and side supports. The crews then fashioned chain action rollers supported by hydraulic jacks to maintain roof support pressure against the crown, especially as the TBM advanced until the front of the roof support skin could be secured in the crown with some rock bolts and straps. The roof support skin and roof support extensions were secured in place using rock bolts and crown straps (See figures 6-7).

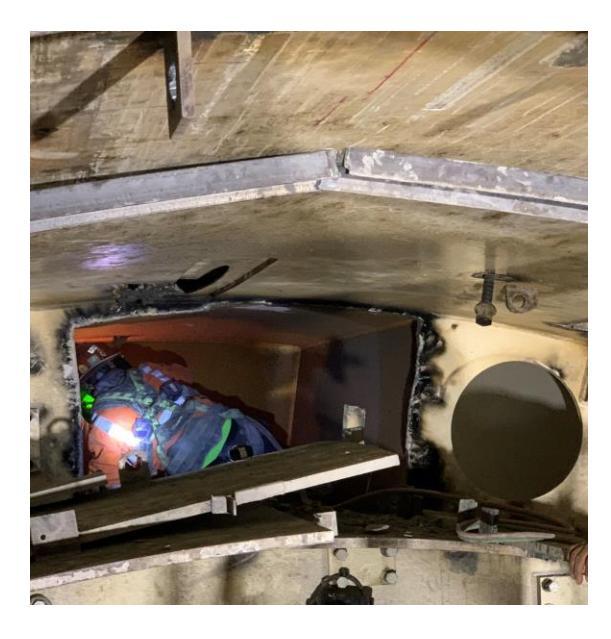
Figure 7. TBM roof shield skin removal

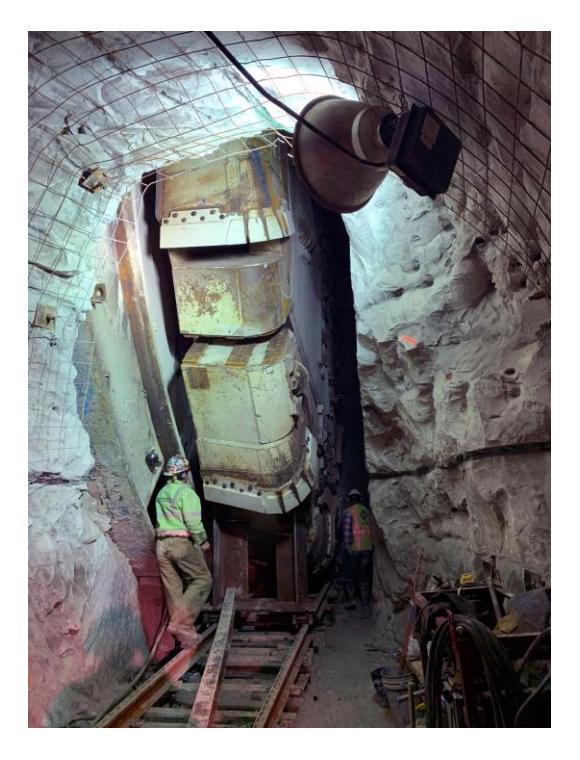
Figure 8. Installation of the smaller diameter cutterhead structure

The vertical front support did not need to be removed from within; the crews needed only to remove the fore and aft welds to free the small diameter TBM and allow the TBM to push off the vertical front support when the time came. The crews carefully fashioned the side support skins and reinforcing ribs into supporting members for the gripper shoe skins. The gripper shoe skins were positioned carefully onto the side support skins and welded in place. A few rock bolts were installed into the side supports to ensure they did not shift as the TBM passed through, and crews worked closely in/on/around them. Once the cutterhead was re-assembled the TBM started mining forward (see Figure 8).

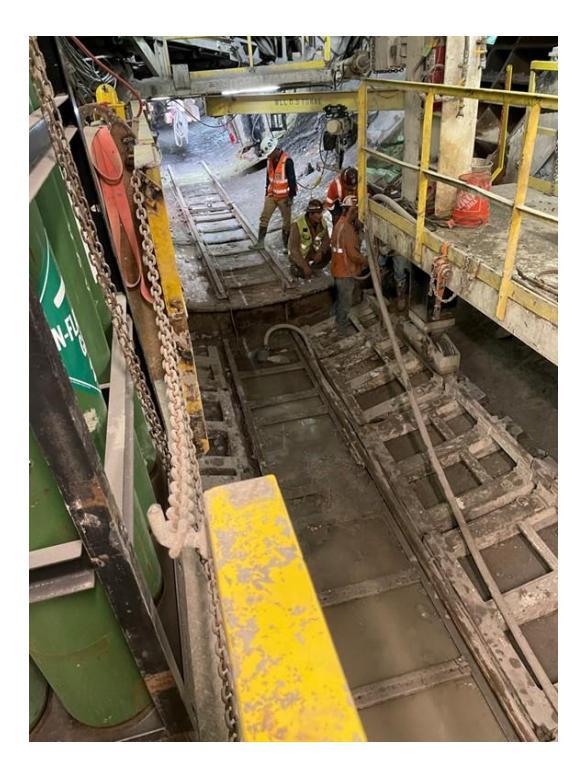
Figure 9. The gantry lift process

The original design was to lead the trailing gear up a 2% slope requiring a substantial amount of civil works to build the ramp between the TBM and the first gantry of the trailing gear. There was not much space within which to work, so this design was not desirable. The bad ground encountered at the diameter change station eliminated the ability to back the TBM more than absolutely necessary. There were several discussions held in an effort to find a workable solution, and ultimately the contractor and Robbins decided a novel approach would work. The decision was to use rented hydraulic cylinders in conjunction with fabricated spacers and raise the entire trailing gear at the same time. This decision naturally created obstacles, but these were overcome (see Figure 9).

While the gripper shoe extensions were being removed the crews installed fabricated supports to the tunnel walls upon which were placed hydraulic jacks. Four jacks were used per gantry with each gantry having a dedicated pump and each jack having a dedicated isolation valve. During the lift crews took careful measurements to ensure the trailing gear raised at the same rate and at no point were any two jacks allowed to become more than 3mm different in extension, thereby ensuring the entire trailing gear lifted equally. (Each jack had a maximum capacity of 45 metric tons so with the maximum weight of the heaviest gantry at 61,700 kg the job was done with a generous safety factor.)

As the gantries were lifted, spacers were inserted as an extra measure of safety until all four gantries were lifted to the correct elevation. The wheel bogies were removed and spacers were installed to the gantries and the bogies

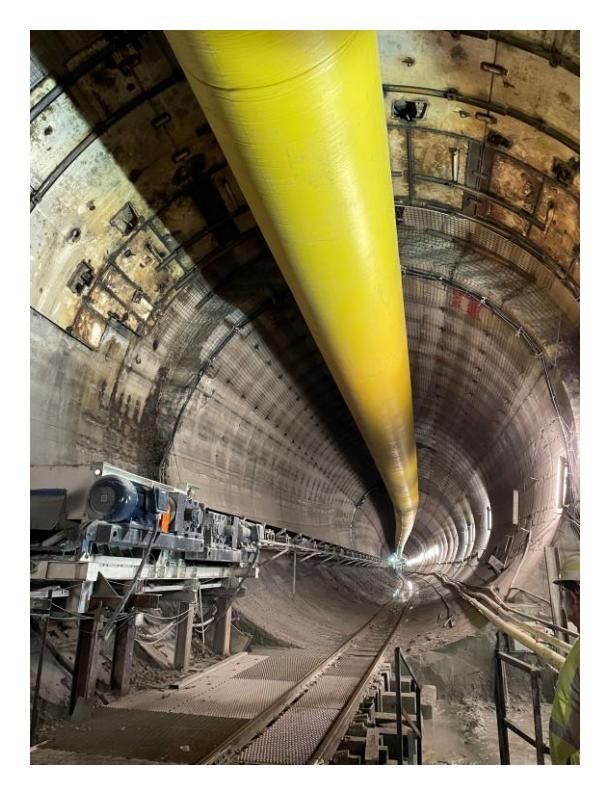
Figure 10. The completed diameter transition area

This process was repeated until all the trailing gear was inside the newly mined tunnel (see Figure 10).

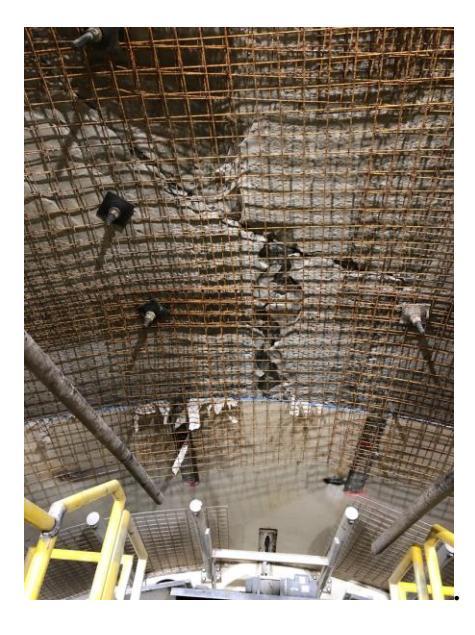
Figure 10. Rock bolts and wire mesh installed in the tunnel crown

The Mill Creek machine is operating in Austin Chalk and Eagle Ford Shale with a compressive strength of between 17 MPa and 30 MPa. The requirement for systematic rock bolting is in part due to the rock being classified as mainly Type III and some areas of Type IV conditions. In Type IV conditions the contract called for eight additional rock bolts, resulting in 76cm linear spacing with wire mesh covering the crown and steel straps as needed. Once through the learning curve the crew began installing eight bolts in the Type III conditions in 20-25 minutes (see Figure 10).
